**PETITION OF THE  
THIEF RIVER FALLS AIRPORT AUTHORITY  
FOR MPCA PERMIT**

# Letter of Correction

**DATE:** November 8, 2010  
**SUBJECT:** Thief River Falls Airport Runway Review.

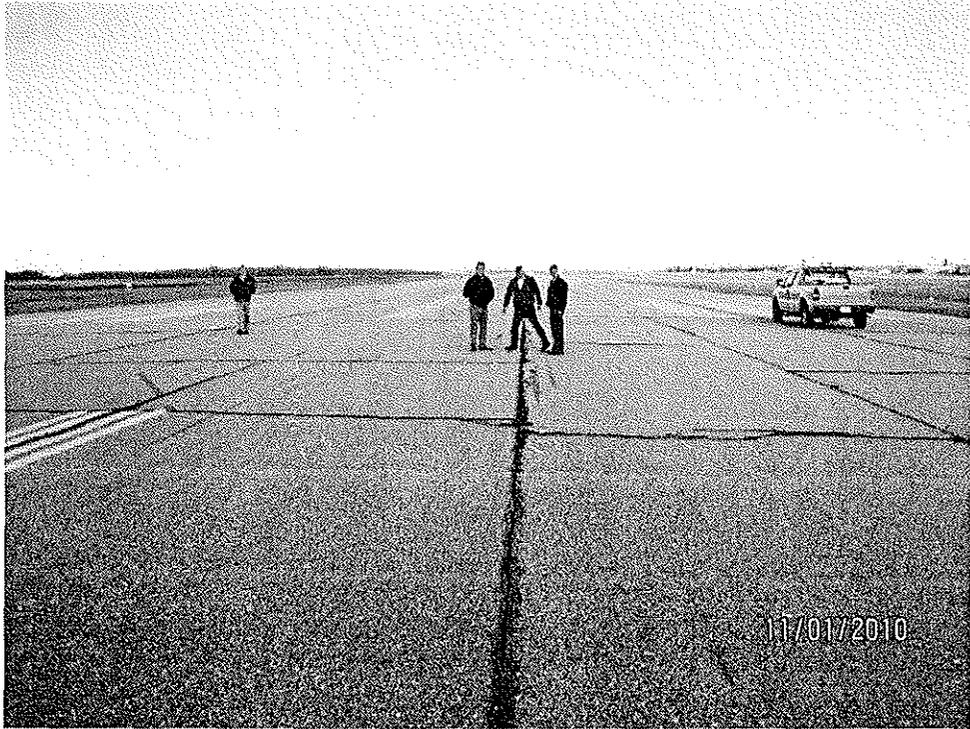
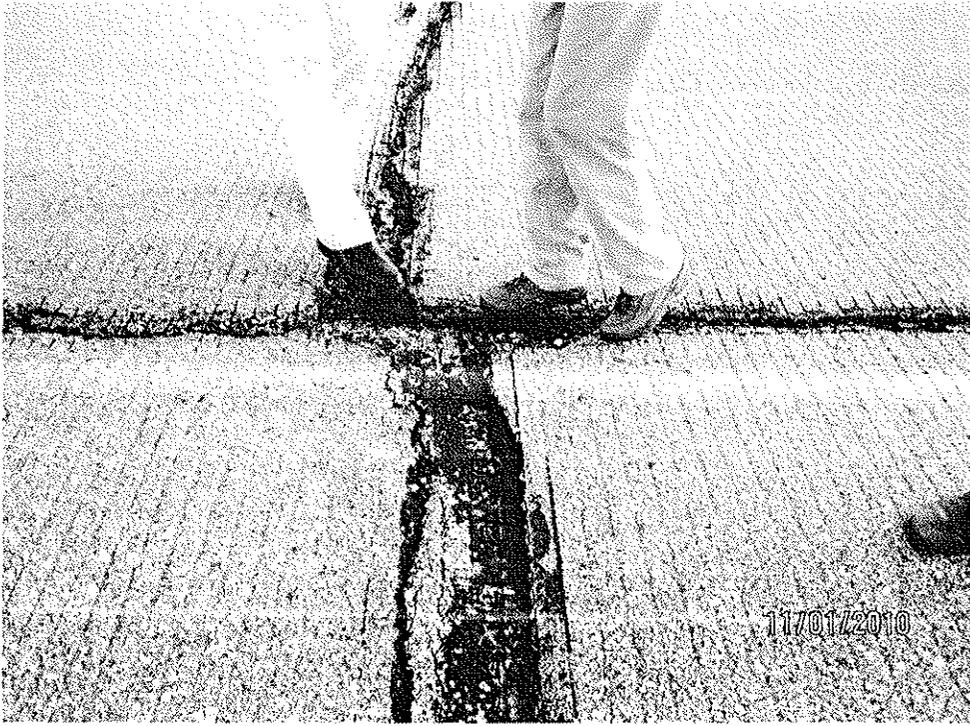
On November 1<sup>st</sup> I had the opportunity to review the Thief River Falls Airport. The main runway is an asphalt pavement approximately 12 inches thick full depth over variable base materials. The last over lay was placed 16 years ago. The reason for the review was to help determine what the best method to improve the condition of the runway. The main issue the runway is suffering from severe cracking. See pictures below. The asphalt away from the cracks is aged and pocked. It is starting to lose aggregate due to loss of fines. The options available in my opinion are the following:

1. Mill three (3) inches and overlay three (3) inches. I do not think this is the best option because the cracks are cupping, average basin of the depressed pavement close to three (3) feet wide. I stepped on some of the pavement alongside the cracks and I could see the pavement depress under my weight. This tells me that the asphalt at the cracks is stripping and losing strength. If mill and overlay goes forward, to fix runway I would recommend doing some test pits over cracks to determine how bad the asphalt is. My best guess is that within two (2) to five (5) years the cracks would be back and as bad as they are now.

2. The second method would be to mill six (6) inches of asphalt and then do full depth recycling (FDR) stabilized with asphalt emulsion followed with six (6) inch overlay. This option would destroy the current crack pattern and would give many years of performance. If the current traffic stays the same this would be my first choice. I strongly recommend using the proper performance grade (PG) of asphalt binder to slow development of new cracks. The new pavement with regular preventive maintenance (crack sealing) should last 15 to 20 years.

3. The third options is to mill off six (6) inches of the existing asphalt and then do FDR stabilized with asphalt emulsion for the remaining asphalt. Pave the stabilized base with eight (8) inches of concrete pavement. This would give the owners a 50 to 60 year fix that in my opinion could handle any increase in traffic and size of planes using airport.
