LEGISLATIVE REPORT ON THE TRANSFER OF OWNERSHIP OF THE RAMSEY DAM

Legislative Report on the Transfer of the Ramsey Dam in Mower County

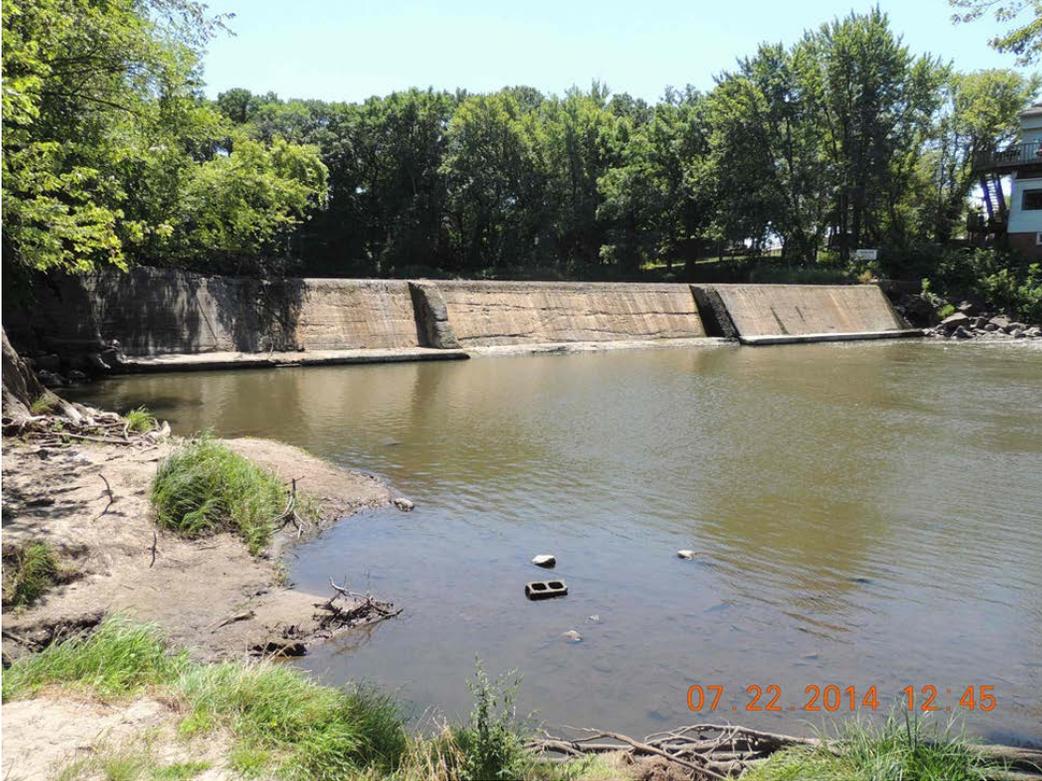
View of dam from downstream side, no water flowing over the spillway.

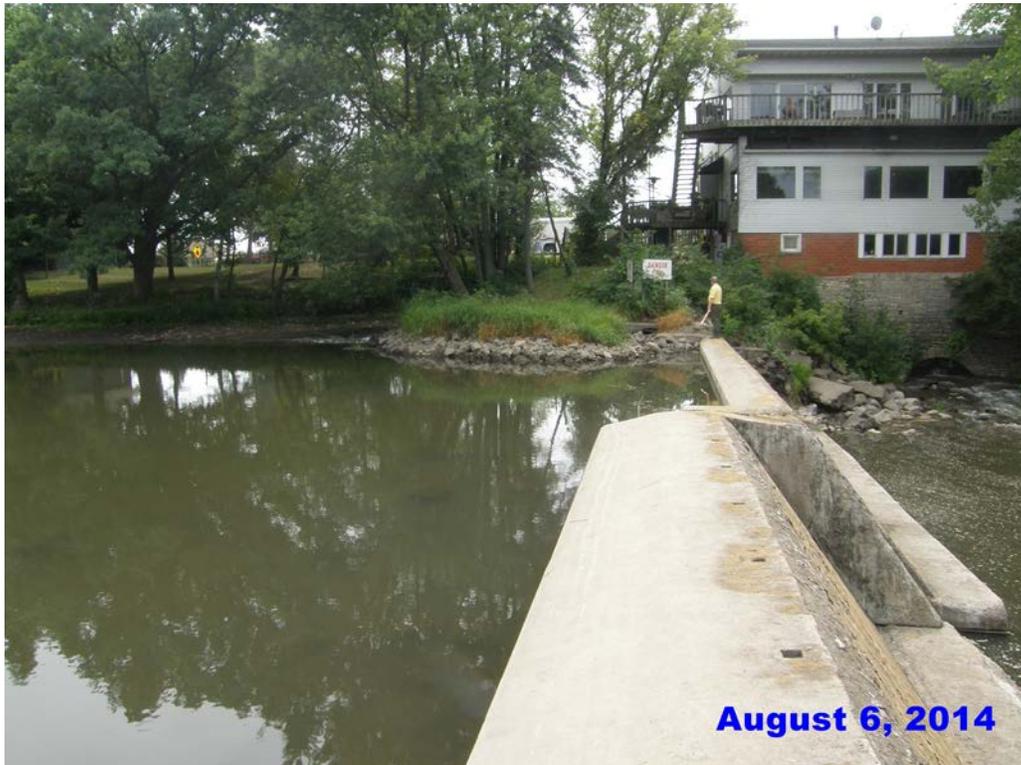
Looking across the dam from the right abutment towards the left embankment and the restaurant (former mill).

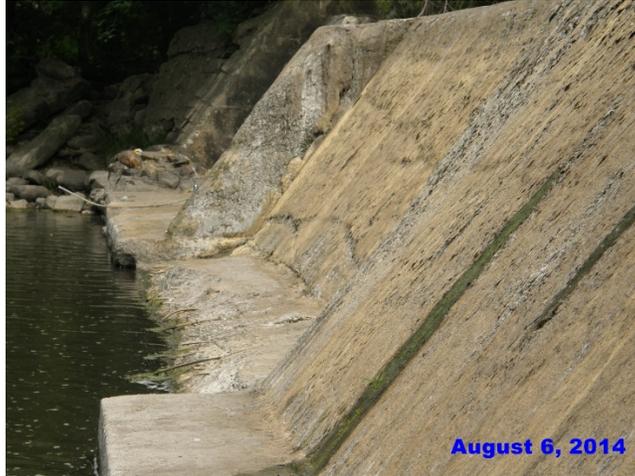
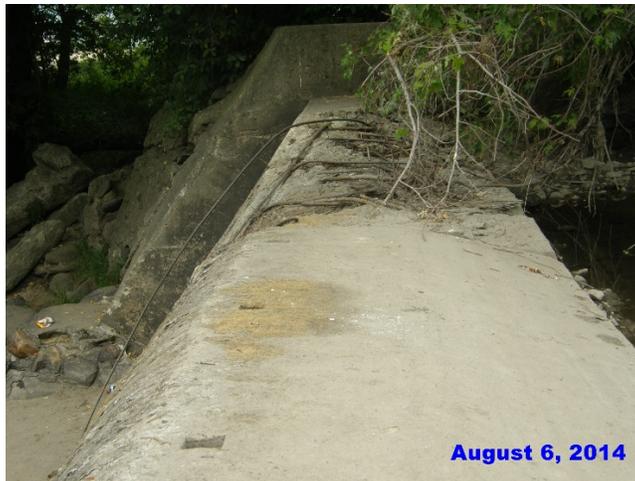
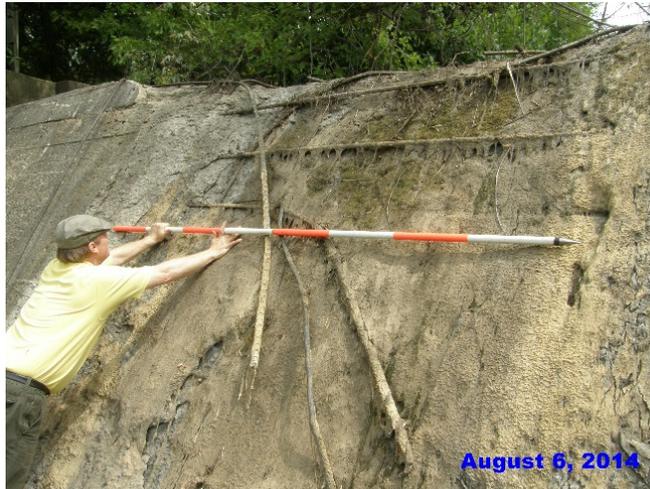
Spillway

The right concrete spillway section needs to be repaired. The concrete on the right section of the spillway is severely deteriorated and has exposed rebar. Pitted areas on the spillway are likely to fail shortly. Intermediate piers are also severely deteriorated. Repairing the right spillway section entails

removing deteriorated concrete and overlaying with new reinforced concrete. Barr Engineering estimated the cost to overlay the deteriorated portion of the spillway at \$422,000.

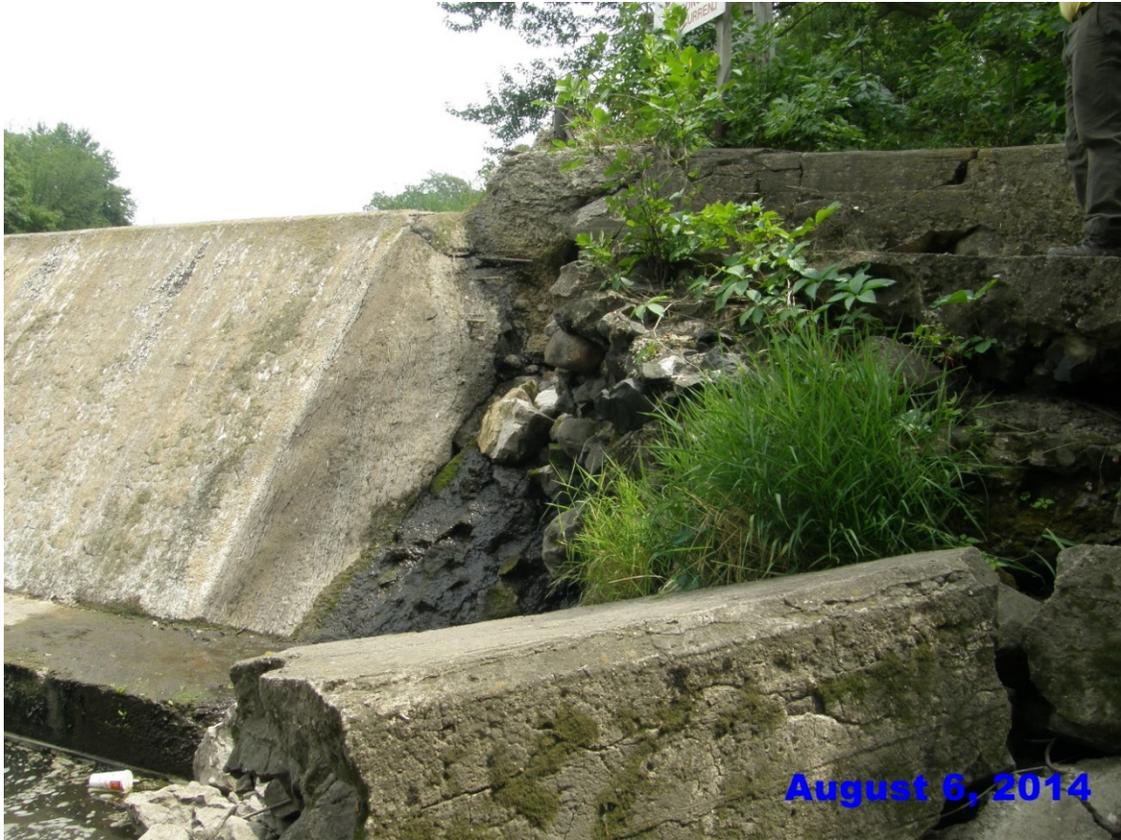
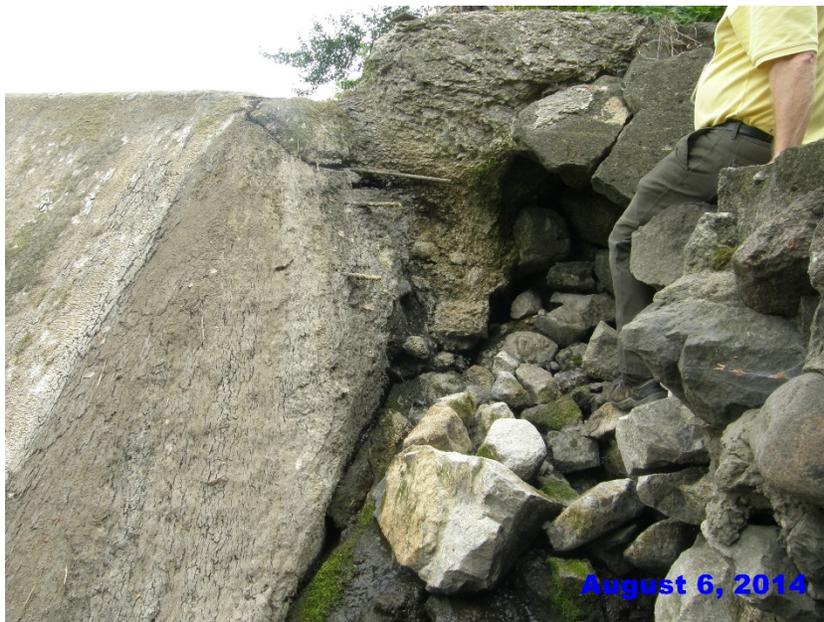
Left Abutment

The stone masonry and reinforced concrete overlay on the left abutment are severely cracked and portions have slipped. Seepage is also occurring on the lower portion of the left abutment. Barr Engineering estimated the cost to install a filter system and riprap protection at \$53,000. Grouting the abutment and stabilizing the dislodged stones was also shown as an option by Barr Engineering.

Uncontrolled seepage is occurring on the lower portion of the left abutment, which could lead to piping of material and eventual failure of the abutment and dam.

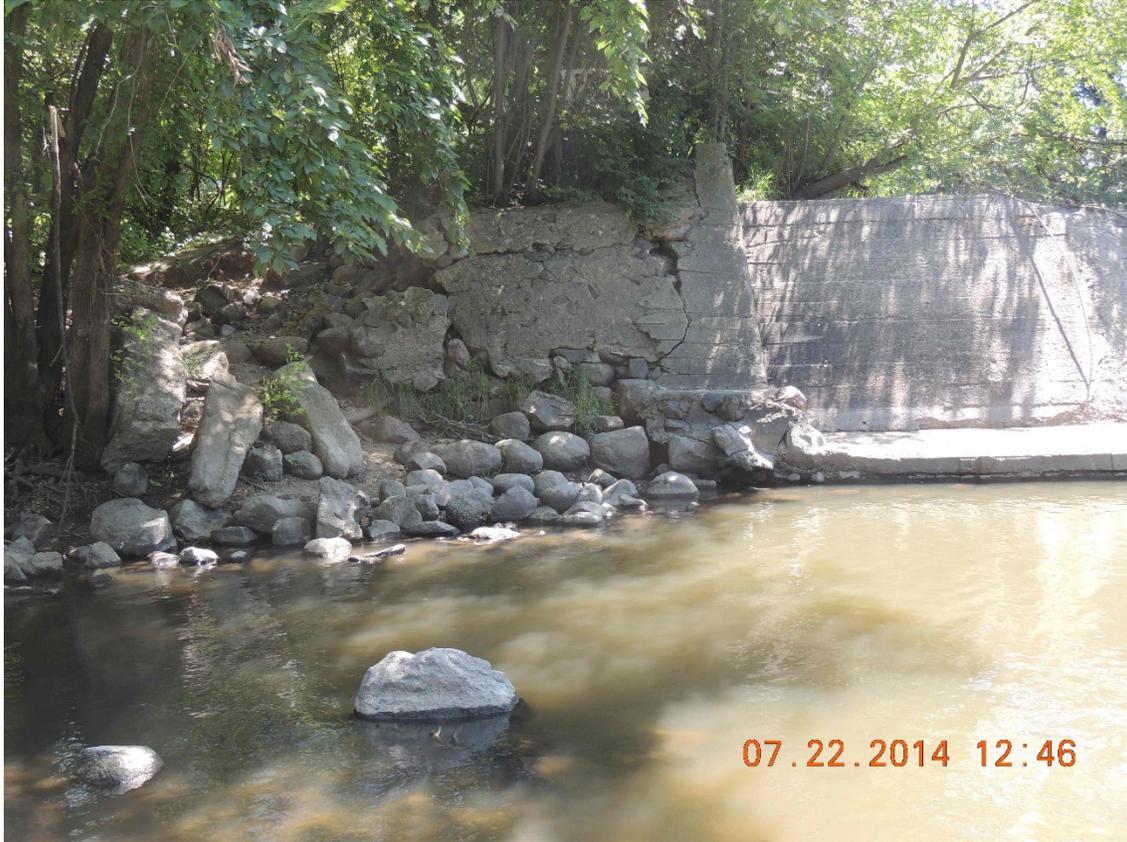
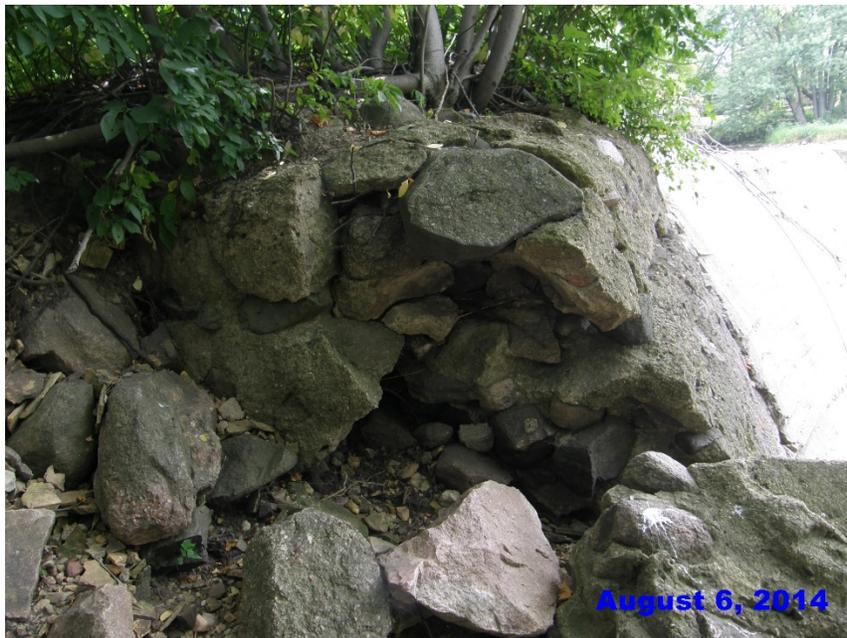
Right Abutment

The right earthen embankment and abutment also need repair. The reinforced concrete overlay and rock on the abutment have slipped. Portions of the abutment and earthen embankment are vulnerable to erosion as they have no armor protection. Historically, the earthen embankments have been overtopped by flood waters, most recently in September of 2016. The unstable condition of the concrete and rock on the abutment are not likely to withstand flood waters. Repairs to this portion of the dam should include stabilizing concrete and rock on the abutment and armoring the abutment and the earthen embankment to withstand erosion from flood water. No cost estimate is provided for this work.
