**INVESTIGATION OF
SEDIMENT & VEGETATION PROBLEMS
LITTLE FALLS RESERVOIR - LITTLE FALLS, MINNESOTA**

**MINNESOTA DEPARTMENT OF NATURAL RESOURCES &
MINNESOTA DEPARTMENT OF TRANSPORTATION**

March 1993

Principal Author: David R. Ford, Surface Water Engineer
Minnesota Department of Natural Resources
Division of Waters

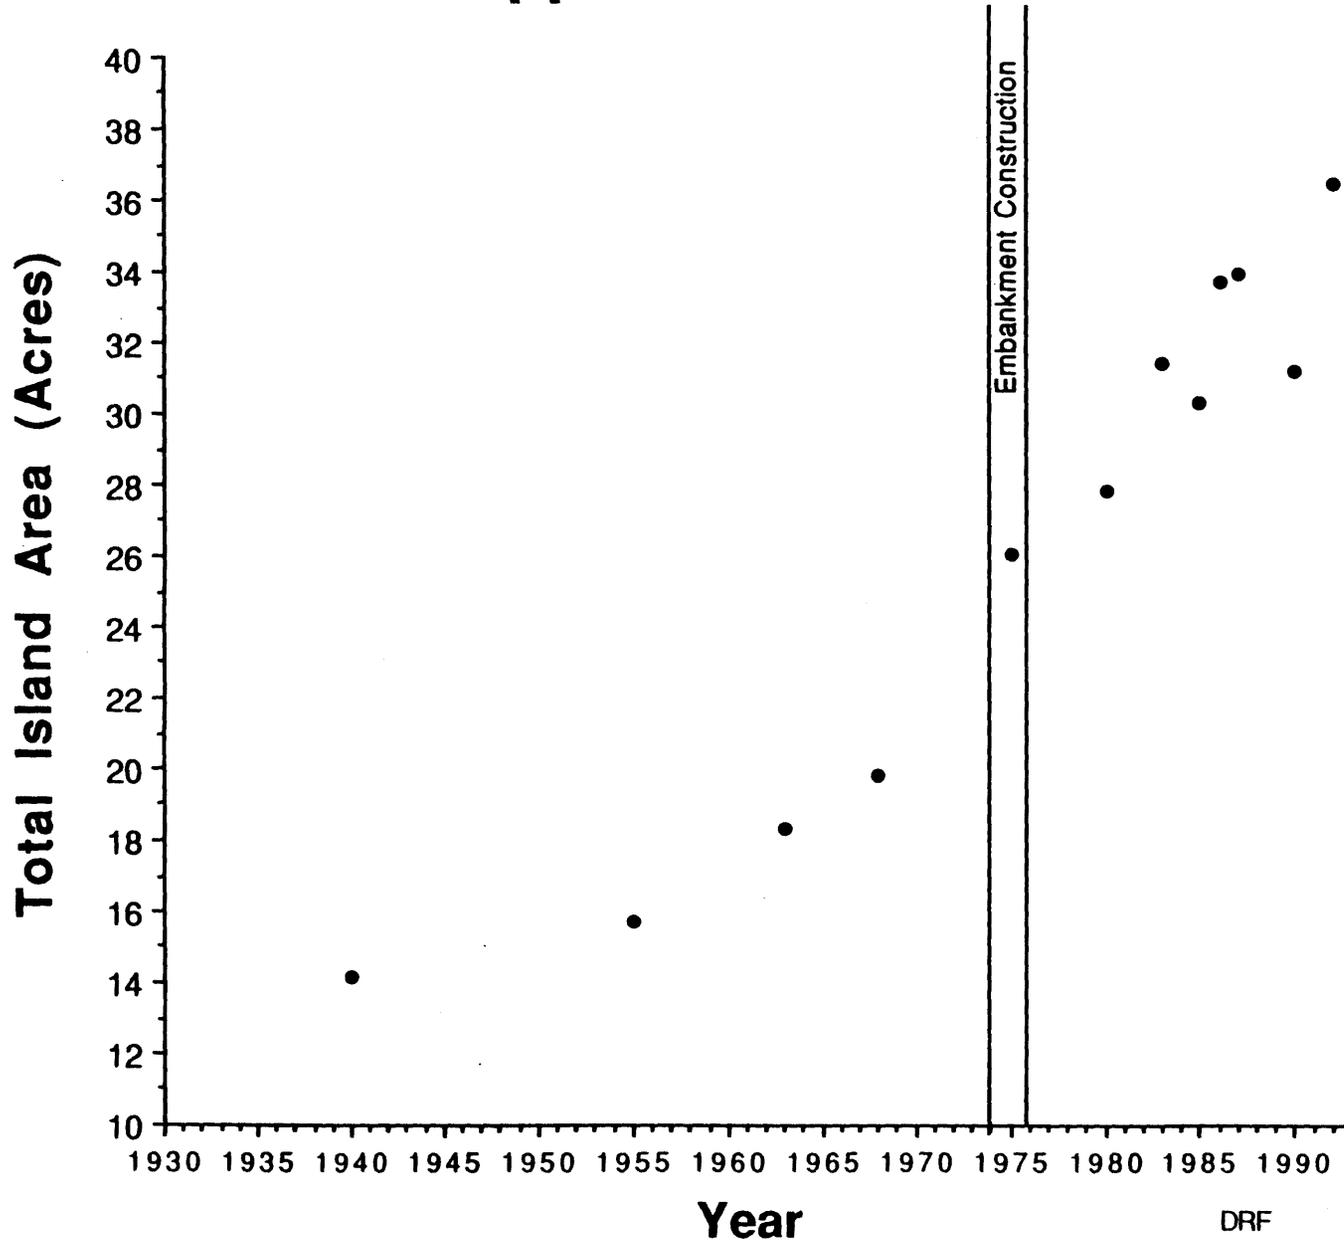
Figure 2 shows how island area has changed over time.

The diagram presented to the author showing total island area as a function of time suggests that the rate of deposition in the deltaic zone has increased somewhat since 1975. Crudely extrapolating using the three pre-closure data points (1955, 1963, 1968), the indication is that 26 acres of island would have formed by 1990. The diagram indicates that 32 acres were actually formed by 1990. (Points for 1986 and 1987 on that graph may have been affected by drawdown, and thus may overestimate island area.)

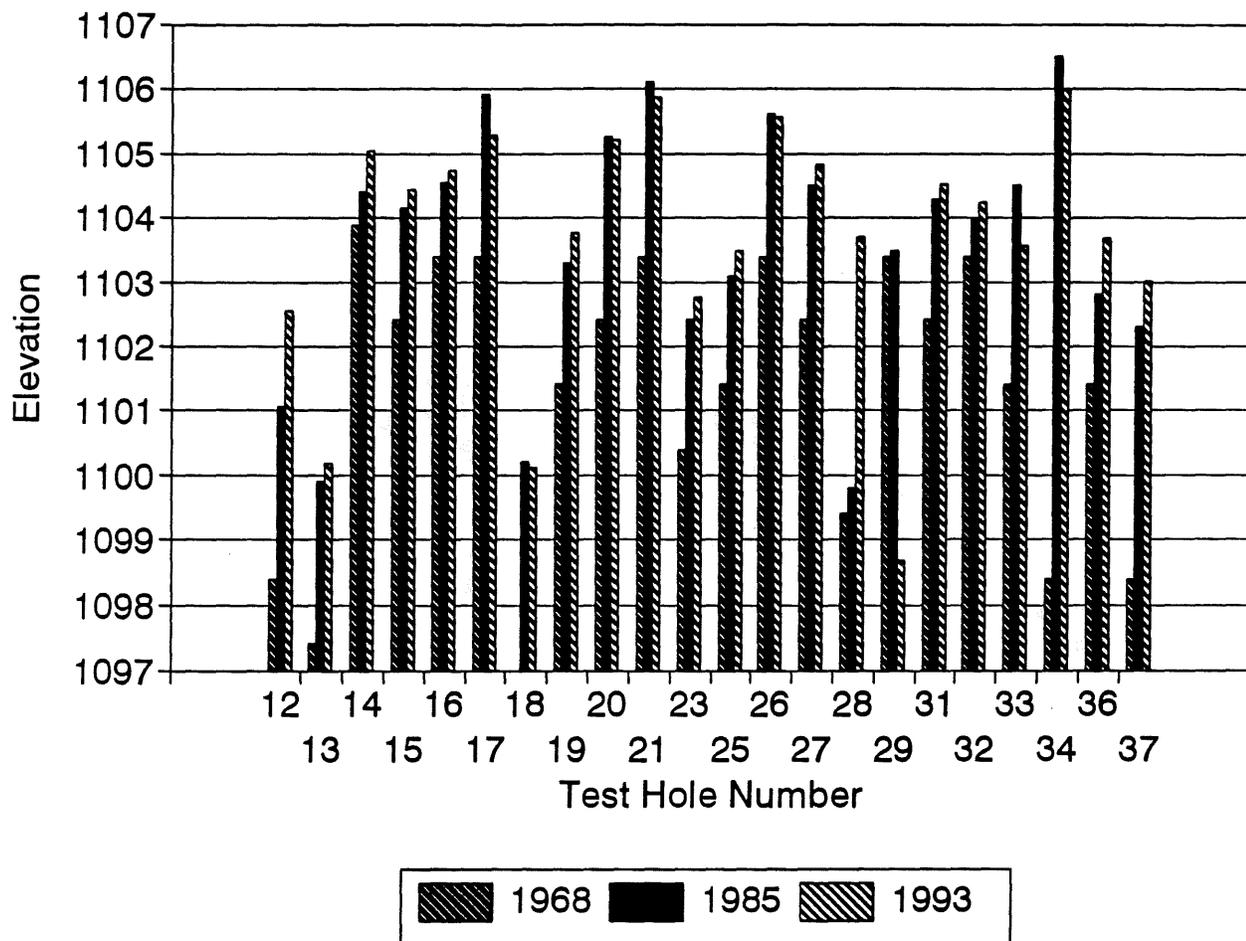
Figure 4

Depth sounding data collected both before and after the embankment was built provide a more direct comparison of how sediment deposition rates have changed. Depth soundings and sediment cores were taken in January 1993 at the same locations where depth soundings had been taken in 1968/1973 and in 1985. The data show that in the area where the soundings were made the average sediment accumulation rate between 1985 and 1993 (0.029 feet/year) decreased compared to the rate for the period 1968/73 to 1985 (0.070 feet/year).

Figure 3 shows locations of individual test holes and Figures 4 and 5 show graphs comparing the change in bottom elevation for various sampling periods.

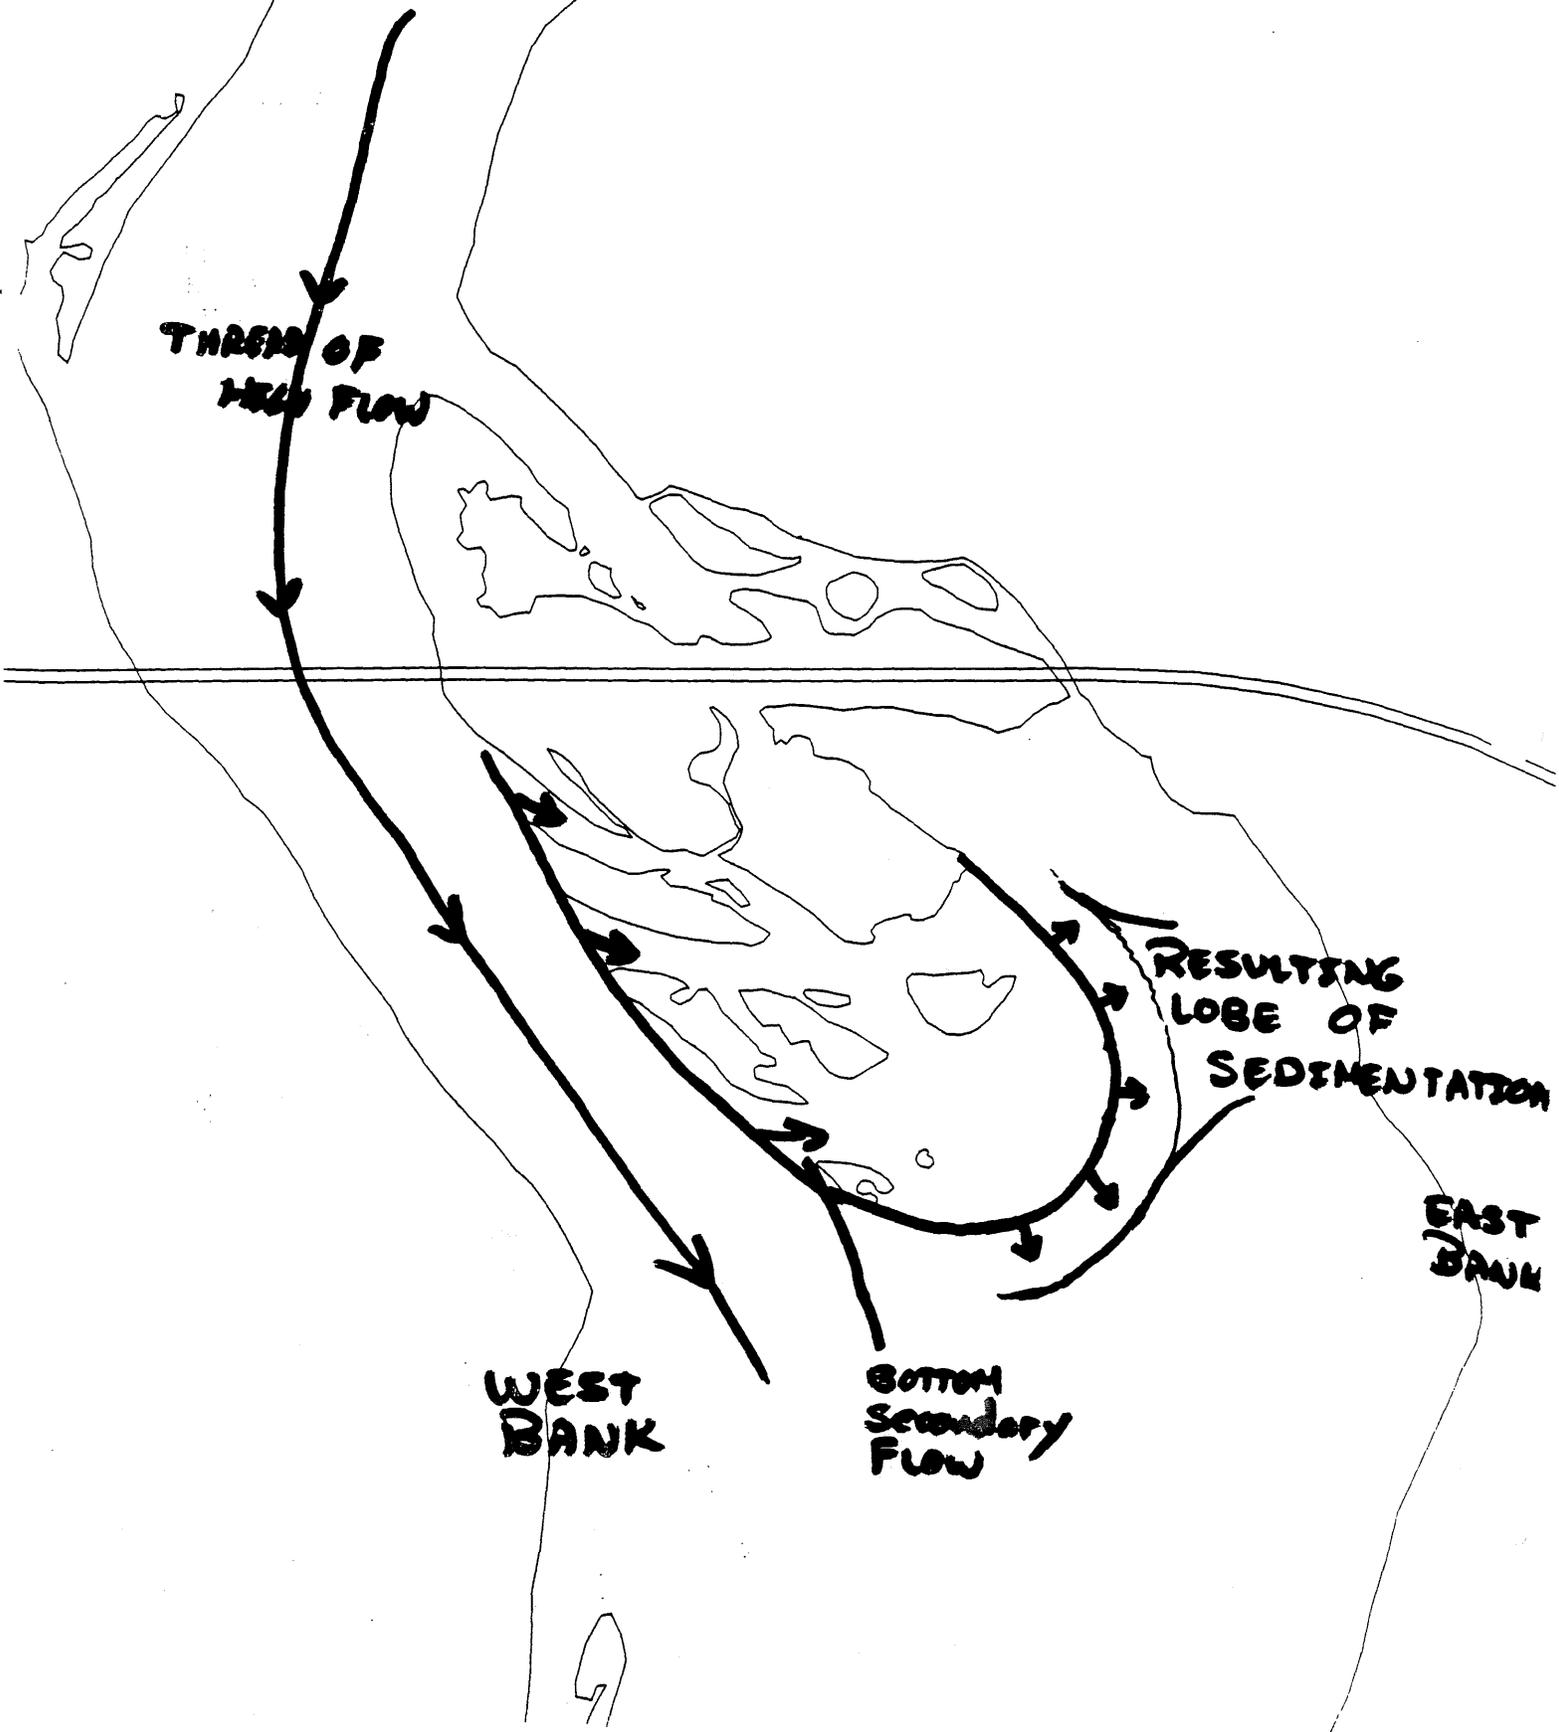
↑
N
FIGURE 2

into islands. By closing the east channel, the growth rate of this lobe should be accelerated at the expense of sedimentation at the mouth of the east channel. The aerial photographs and overlays argue strongly for this effect.

In terms of sand deposition and island formation, then, the following conclusion can be reached with some degree of confidence. Downstream of the bridge, closure of the east channel has likely reduced the rate of sand deposition between the east channel and the east bank of the reservoir, and increased it between the main channel and the east channel. The net result is likely a lower rate of sand deposition along the east bank of the reservoir than would have resulted if the east channel had not been closed.

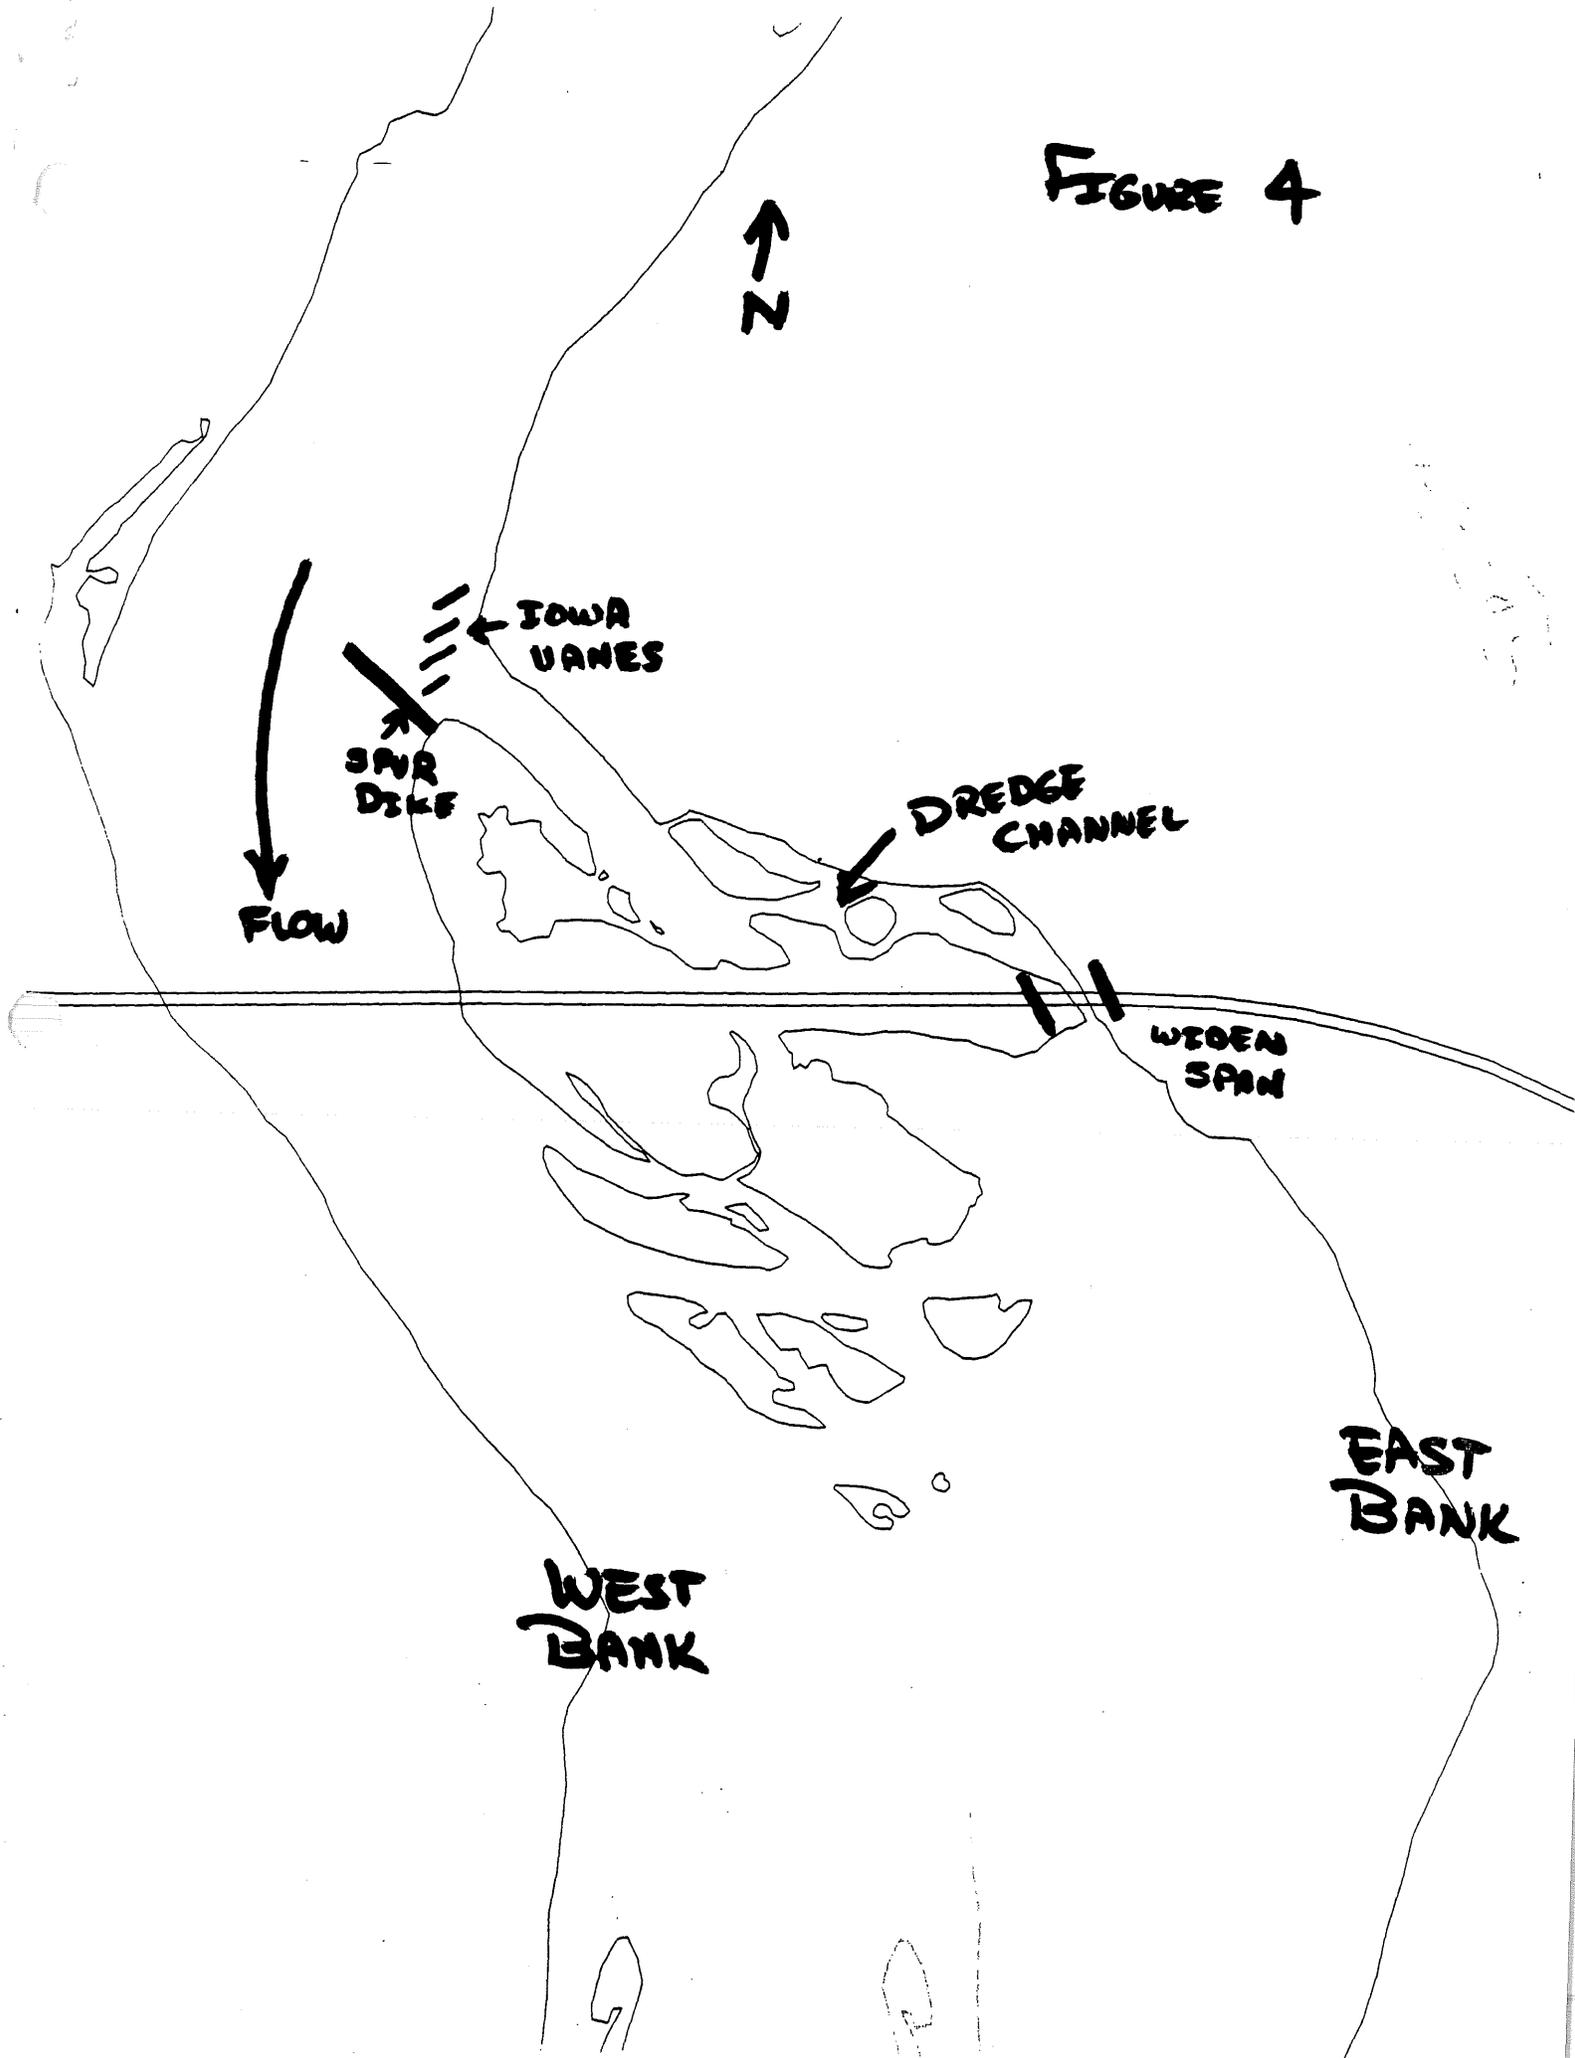
FIGURE 4

One proposal to help alleviate the deposition is the construction of a spur dike at the head of the small channel in order to bring more flow along the east bank of the reservoir. This is shown in Figure 4. As long as the silted zone is shallow covered by aquatic vegetation, however, even substantially increased flow is unlikely to result in removal of existing deposits. Indeed, if the flow brings more sediment, the vegetation may act to retard near-bottom flow and cause fine sediment to deposit anyway.
