MINNESOTA RIVER DAM, GRANITE FALLS

NATIONAL DAM SAFETY PROGRAM

INSPECTION REPORT

OCTOBER 1978

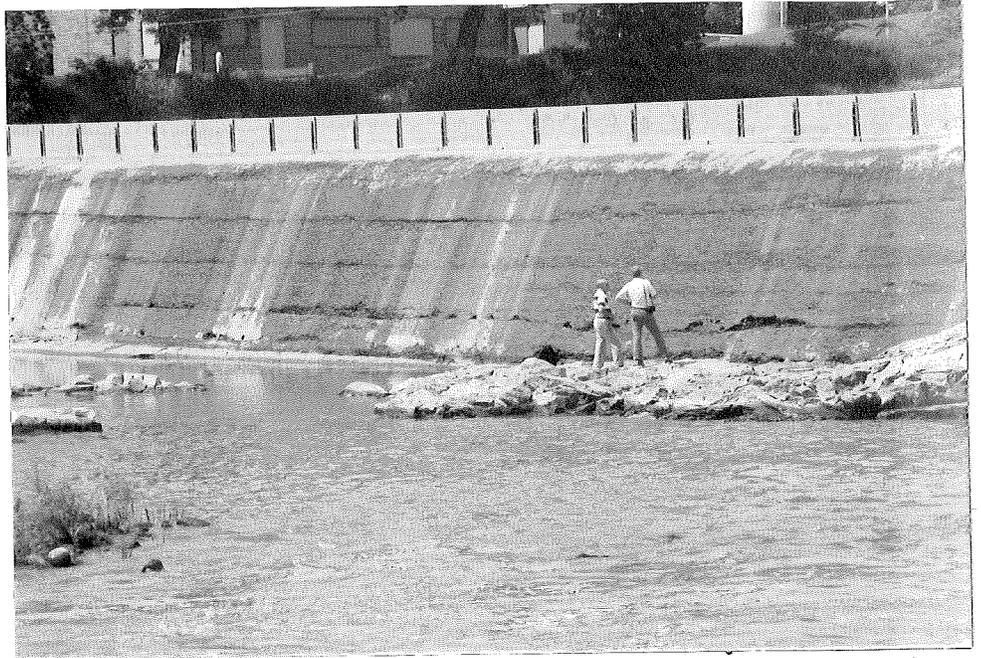
The quality of the concrete in the dam is quite variable. The right half is very bad in surface appearance. The surface scaling has exposed much reinforcing steel both at the crest of the spillway and along the base of the downstream face. The construction joints of the lifts are also very poor, with large voids and exposed coarse aggregate. The deterioration would appear to be largely a surface condition, since there is no indication of seepage through these joints.

Photo 3. Right downstream face of dam showing cold joints and wood flash boards in place on dam crest.

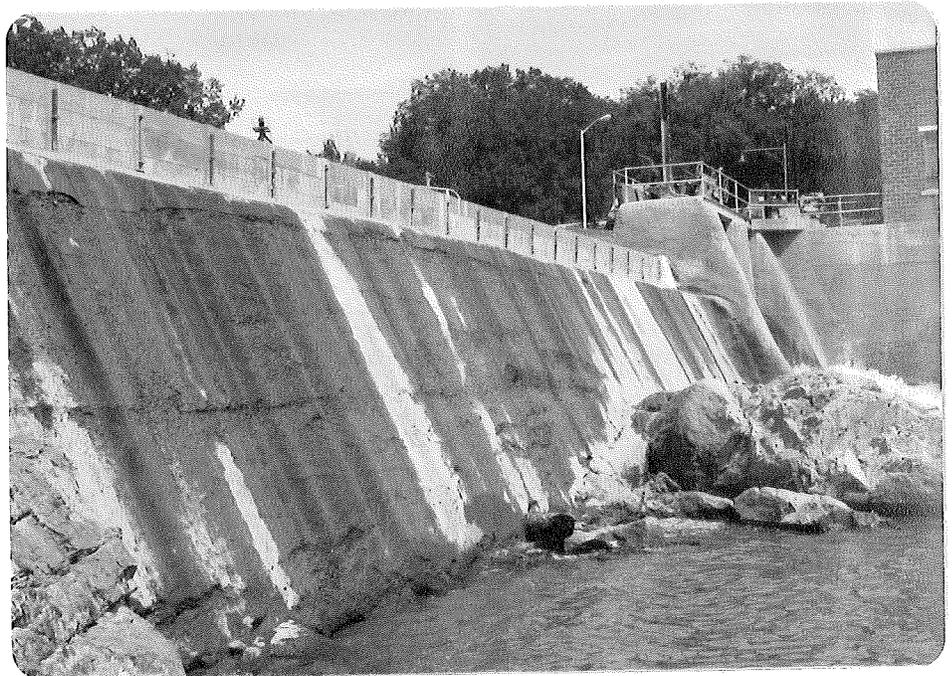
The left half of the dam is slightly better. The crest has been capped with a newer concrete surface. The downstream face has some of the same deteriorated appearance but does not look quite as severe as on the right half of the dam.

Photo 4. Left section of dam showing downstream face with gate section and powerhouse in background.

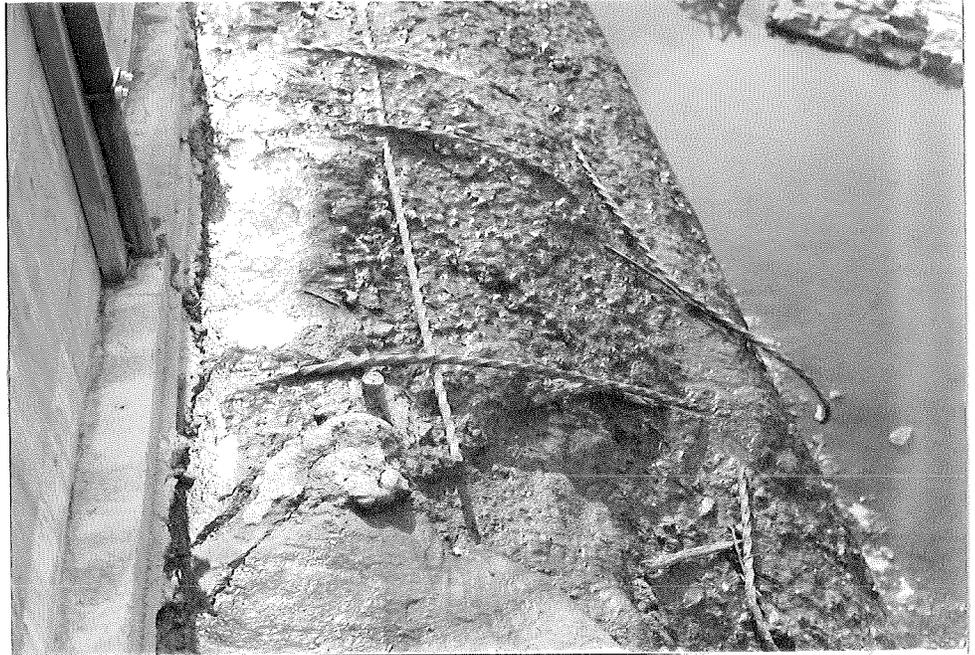
The quality of the concrete in the dam is quite variable. The right (west) half is very bad in surface appearance. The surface scaling has exposed much reinforcing steel, both at the crest and along the downstream face of the spillway. There are large voids and exposed coarse aggregate at the horizontal joints between lifts, however, this would appear to be largely a surface condition, since there is no indication of seepage through these joints. The concrete quality of greatest concern is in the relatively thin walls of the gate structure. In an attempt to improve appearance, the concrete has been covered with a layer of shotcrete. In some sections this layer has a hollow sound when tapped, indicating poor bond and possibly voids. There is also a question on the quality of the concrete beneath the shotcrete. Because of the vital role this structure plays in the operation of the dam, it is recommended that the structural integrity of the gate structure be checked in more detail, possibly by coring or drilling into the mass to evaluate the characteristics of the concrete. With regard to the safety hazard involved in the sudden failure of the 28 foot long gate section, a flood wave of perhaps 7 feet in height could be produced if failure occurred with the gates closed. Because of the limited width of the gate section the initial wave height would rapidly diminish as it proceeded downstream. Failure of the entire section with the gates open would produce a smaller wave.

If there are major geotechnical concerns with this structure, it would probably be in the area of concrete deterioration and quality. The appearance is very bad in many sections with exposed steel and exposed aggregate. Many of these do not pose a severe safety problem, as the gravity dam is not in danger of falling apart. The exception to this may be in the gate structure where the stresses are greater and the deterioration may be more extensive. The entire gate structure is in need of repair and the quality of the concrete should be completely investigated.

Photo 5. View of right spillway crest showing exposed aggregate and reinforcing bars.

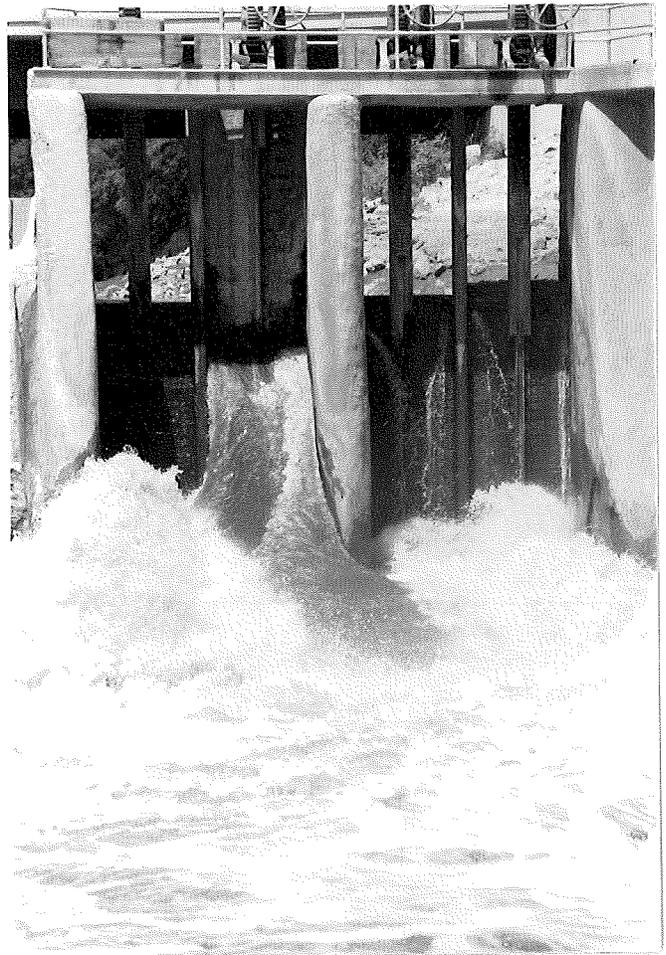
Photo 7. Discharge through the one sluice gate which is operational.

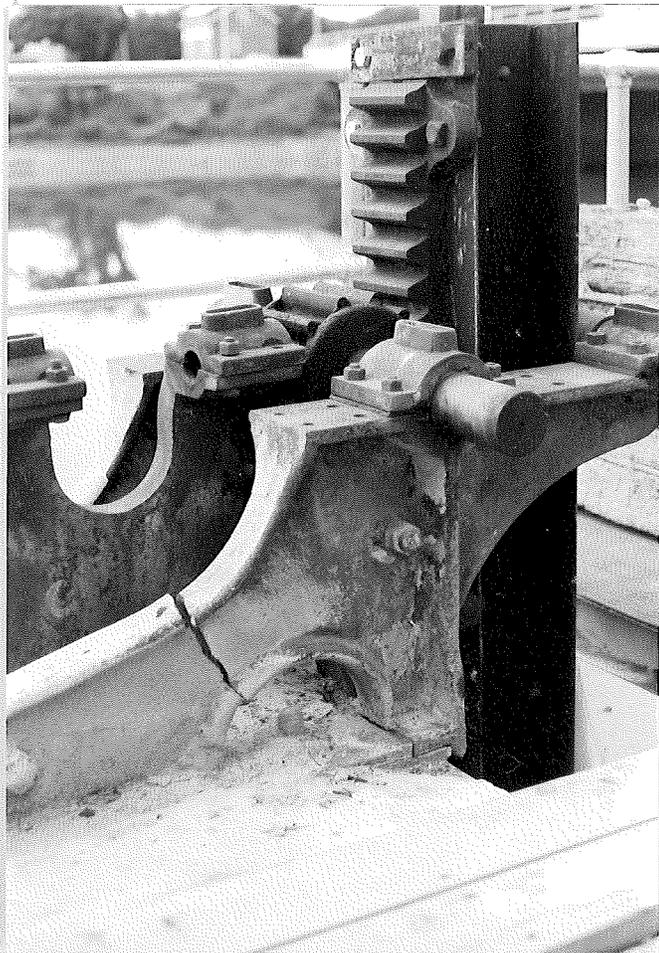
The vertical lift gates at the gate section and powerhouse are operated manually through a gearing arrangement. The mechanical equipment is in very bad condition and operation of the gates requires a large expenditure of manpower and equipment. In view of the vital role played by the gate section in the overall operation of the dam and the deficiency in total discharge capacity of project it is recommended that the gates and gate mechanism be replaced.

Remarks: Two lifting bases cracked, additional deterioration of gate ^{accessories} ~~esseries~~ could make them ^{inoperable} ~~operable~~ which would lessen pool control.

Photo 8. Broken sluice gate machinery which prevents operation of gates.

1. City should take steps to repair the spillway gate operating mechanism..
2. and check quality of concrete in spillway gate control structure,
3. however, failure of gate operation or gate super structure should not
4. effect the safety of the dam.
5. _____
6. _____
7. _____
8. _____
9. _____
10. _____
11. _____
12. _____
