Report to the Legislature: Ford Building Preservation and Use

Ford Building Working Group

January 15, 2006

FORD
BUILDING
Predesign Assessment
&
Renovation/Reuse
Scenarios

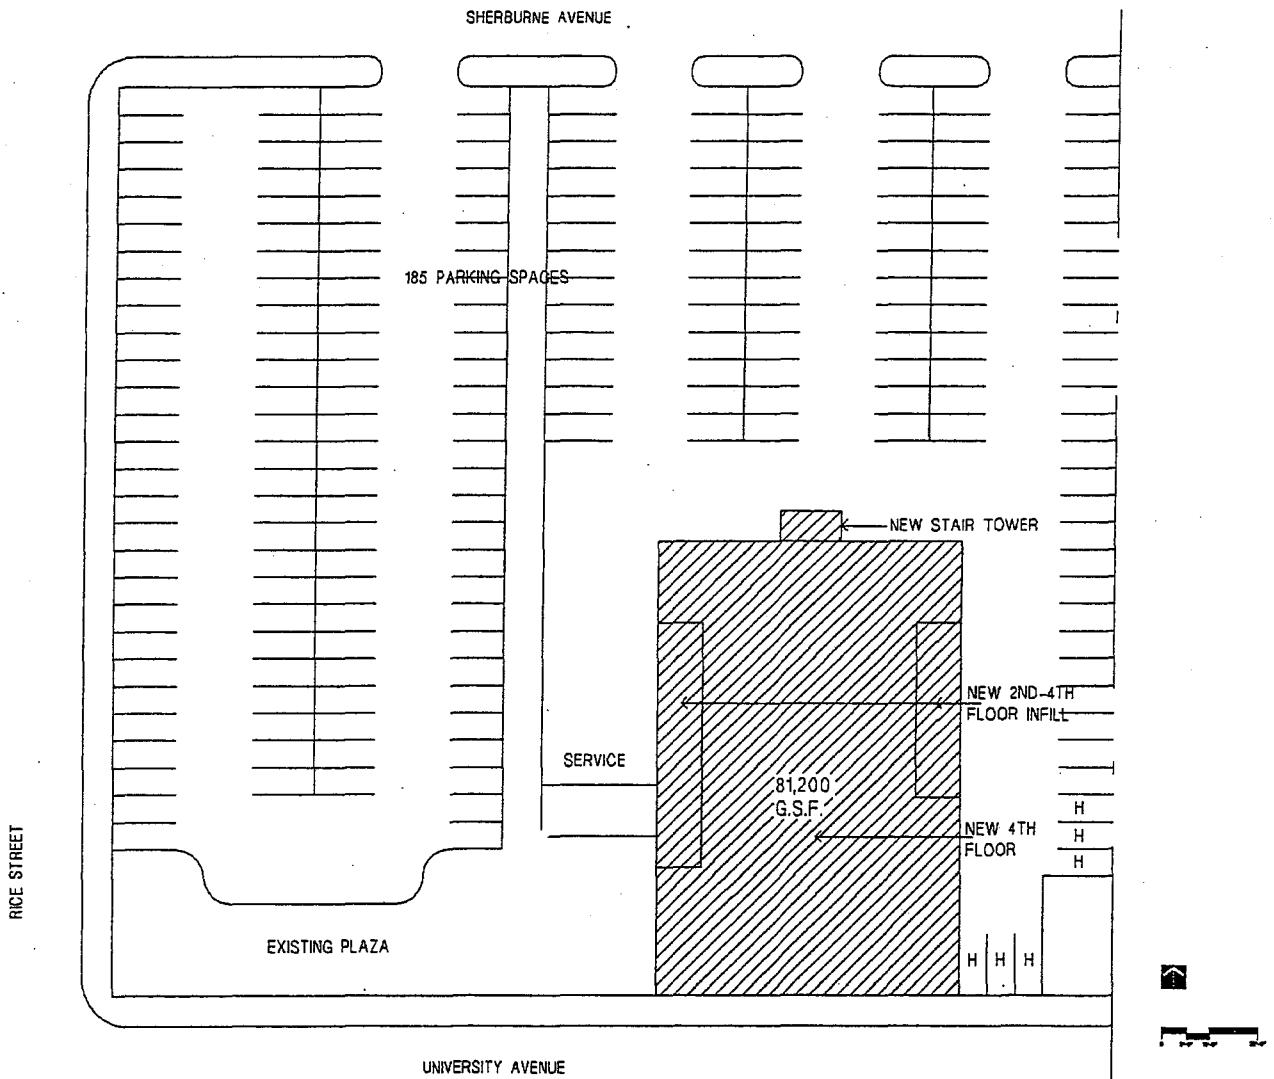
Renovate and expand the existing building within its current footprint to correct conditions of exterior envelope, unused floor areas, circulation/access issues, sustainability, code compliance issues, and structural/mechanical/electrical conditions. These renovations and expansions will result in a renovated building of approximately 81,200 Gross SF (57,170 SF now), with 68,500 rentable SF (51,218 SF now).

- Site remains as is. No changes needed. See "Appendix C" for a scaled plan of Scenario #1.

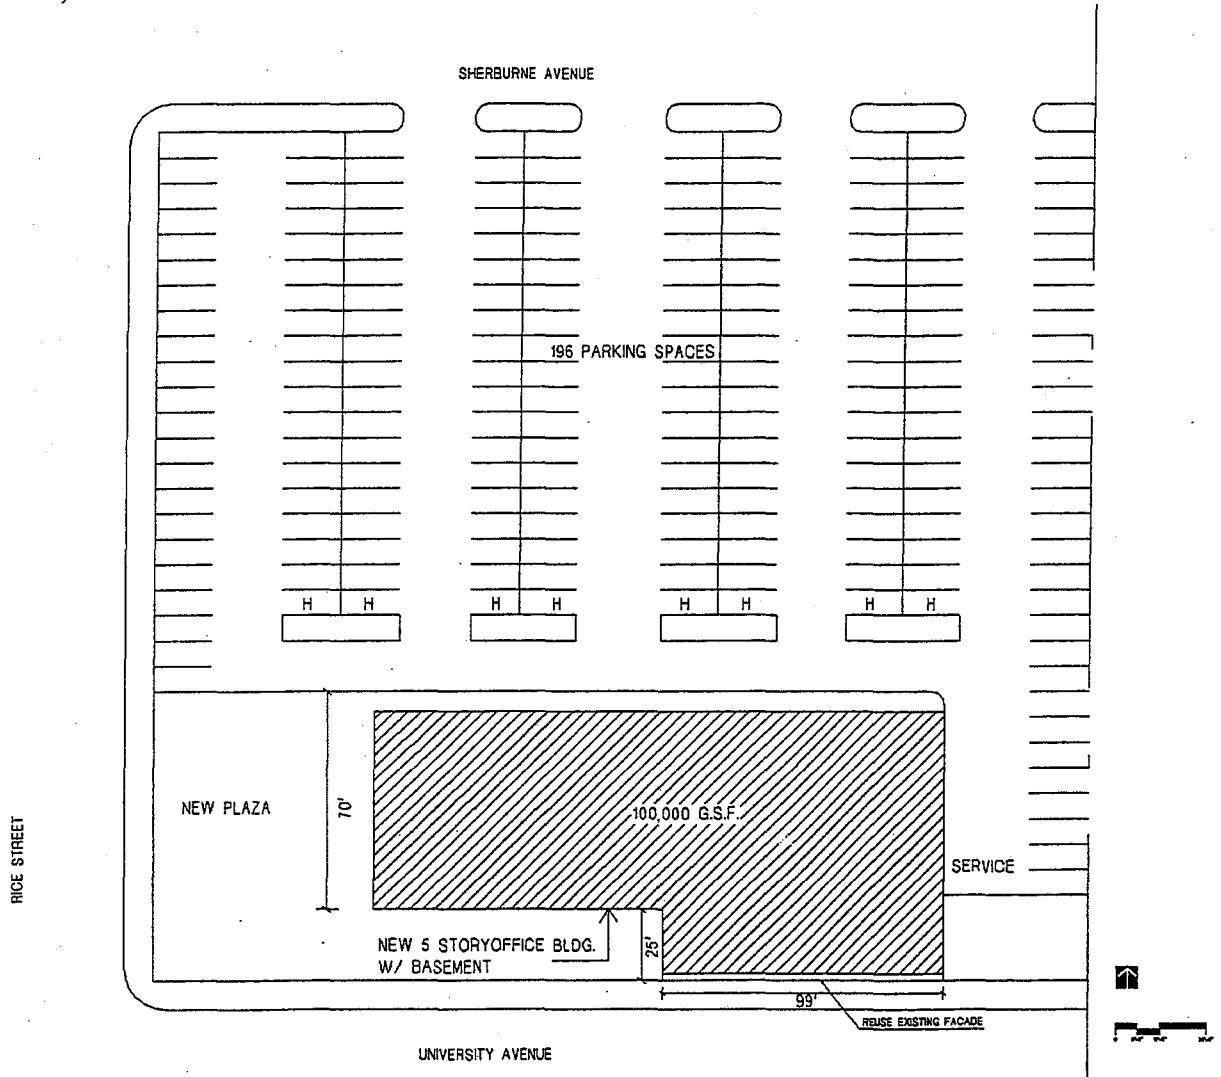
Demolish existing building and construct a steel-framed, 5 story building, plus basement. The new building would approximate (but in a more efficient footprint) the existing building's volume (after renovation in Scenario #1 outlined above). Resulting new building of approximately 100,000 Gross SF, with 89,500 rentable SF.

- Extend parking of existing pattern to the south to provide additional parking for new building volume. See "Appendix C" for a scaled plan of Scenario #2.

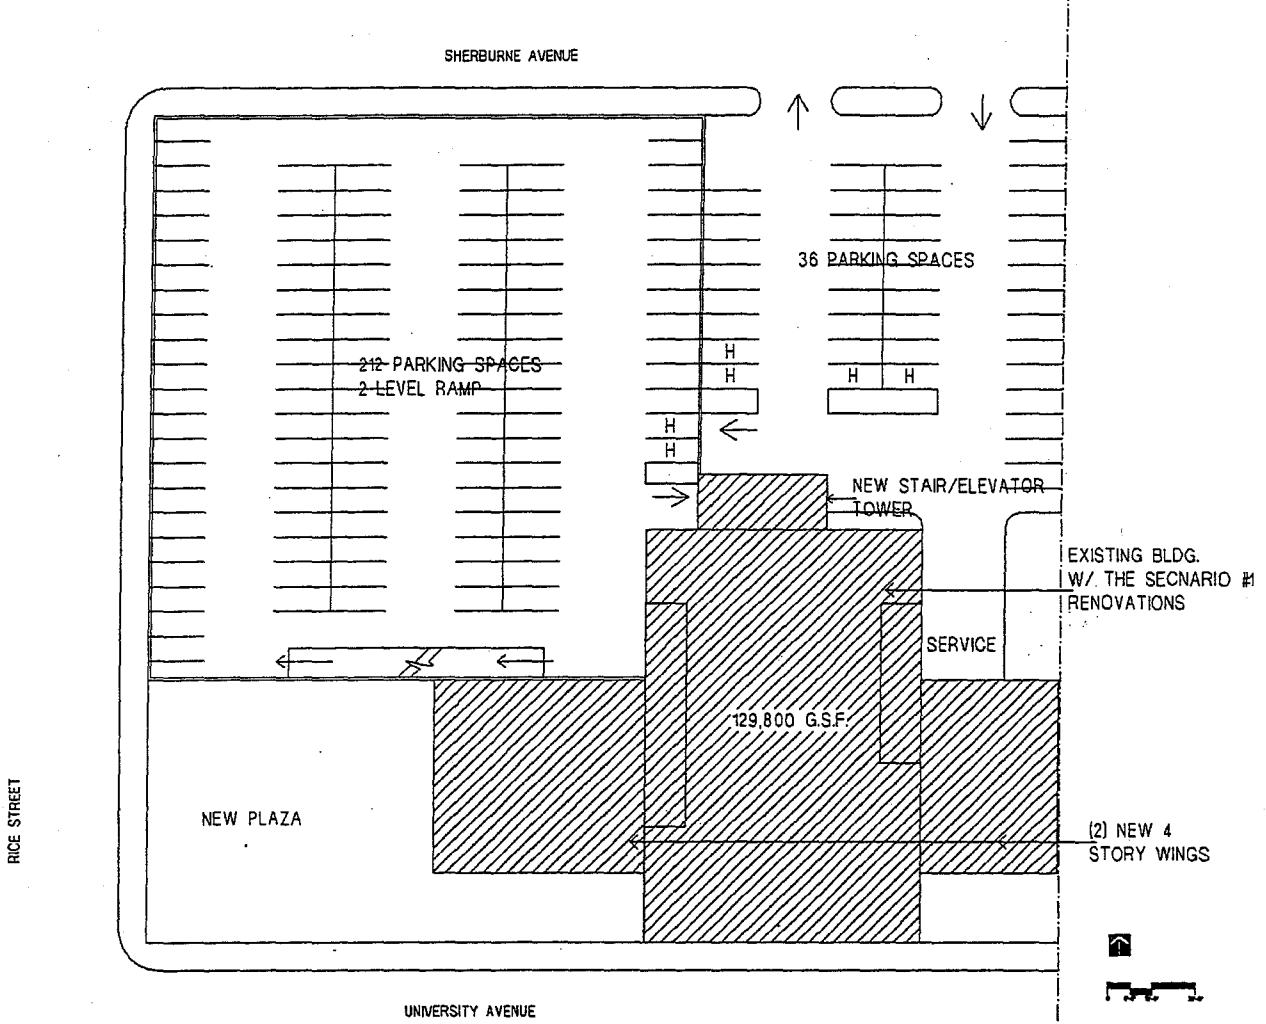
This scenario would retain the existing building and renovate and add to it. The existing building's volume (after renovation in Scenario #1 outlined above) would be increased by adding a new 4 story addition (plus basement) to both the east and west sides of the existing building. Resulting new building of approximately 129,800 Gross SF, with 115,000 rentable SF.

- Construct a two level concrete and brick veneered parking ramp on northwest and west side of site to provide additional parking for new building volume. See "Appendix C" for a scaled plan of Scenario #3.

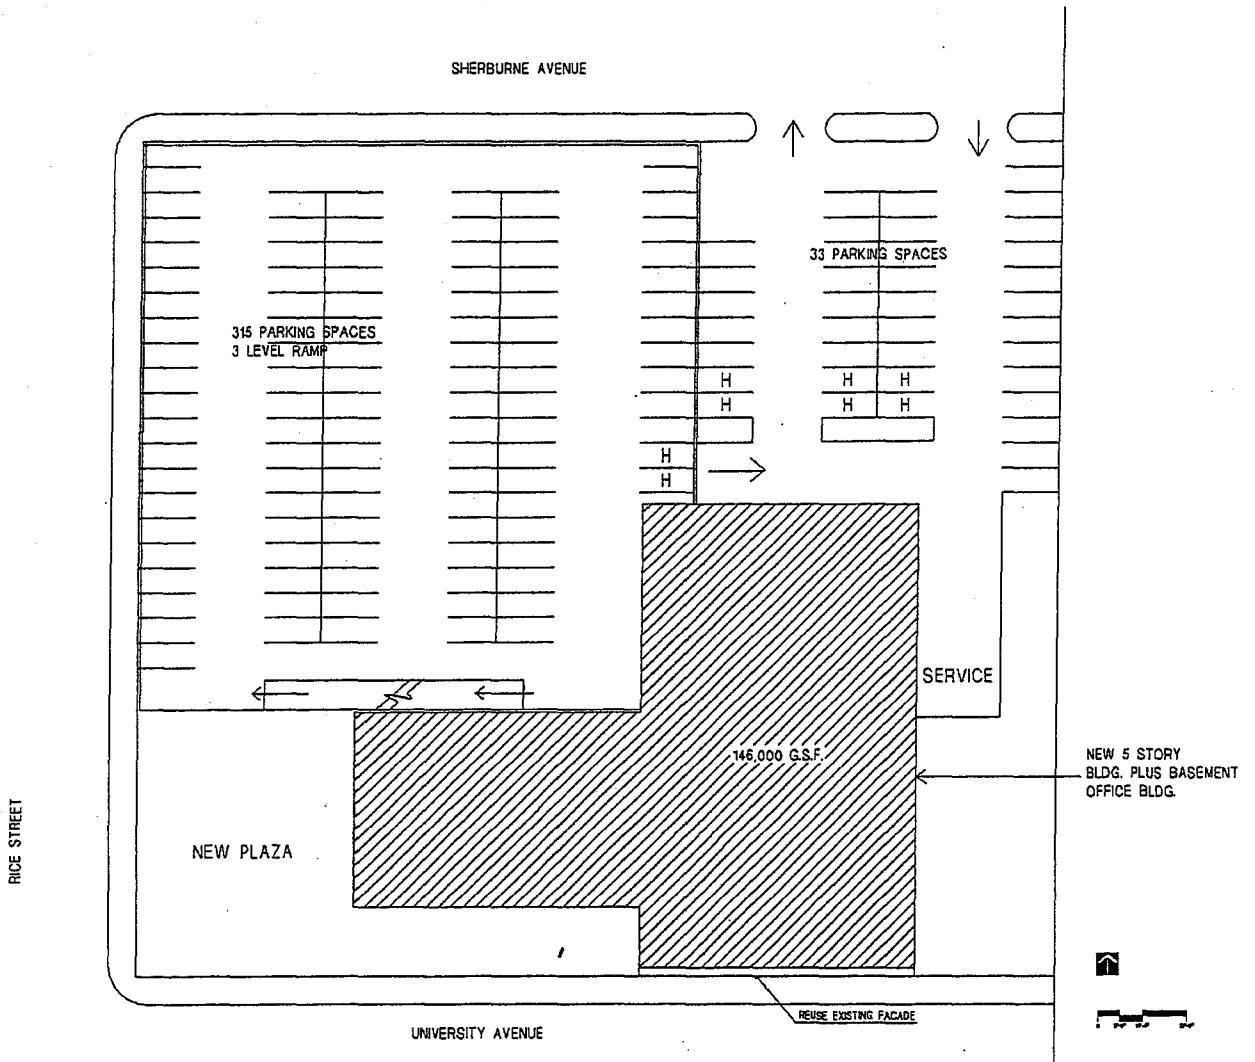
Demolish existing building and construct a steel-framed, 5 story building, plus basement. The new building would approximate (but in a more efficient footprint) the existing building's volume (after renovation in Scenario #1 outlined above). Resulting new building of approximately 146,000 Gross SF, with 128,500 rentable SF.

- Construct a three level concrete and brick veneered parking ramp on northwest and west side of site to provide additional parking for new building volume. See "Appendix C" for a scaled plan of Scenario #4.
