"AFTON: A MINNESOTA STATE PARK DEVELOPMENT
PROJECT RECONNAISSANCE SURVEY"

Prepared for the
Minnesota Department of Natural Resources
Division of State Parks

June 1981

An archaeological reconnaissance survey was undertaken in May 1980 on several development projects in Afton State Park, Washington County. While an occasional isolated artifact was recovered, the area was surprisingly devoid of prehistoric resources. Extensive surface examinations and many shovel tests were all negative.

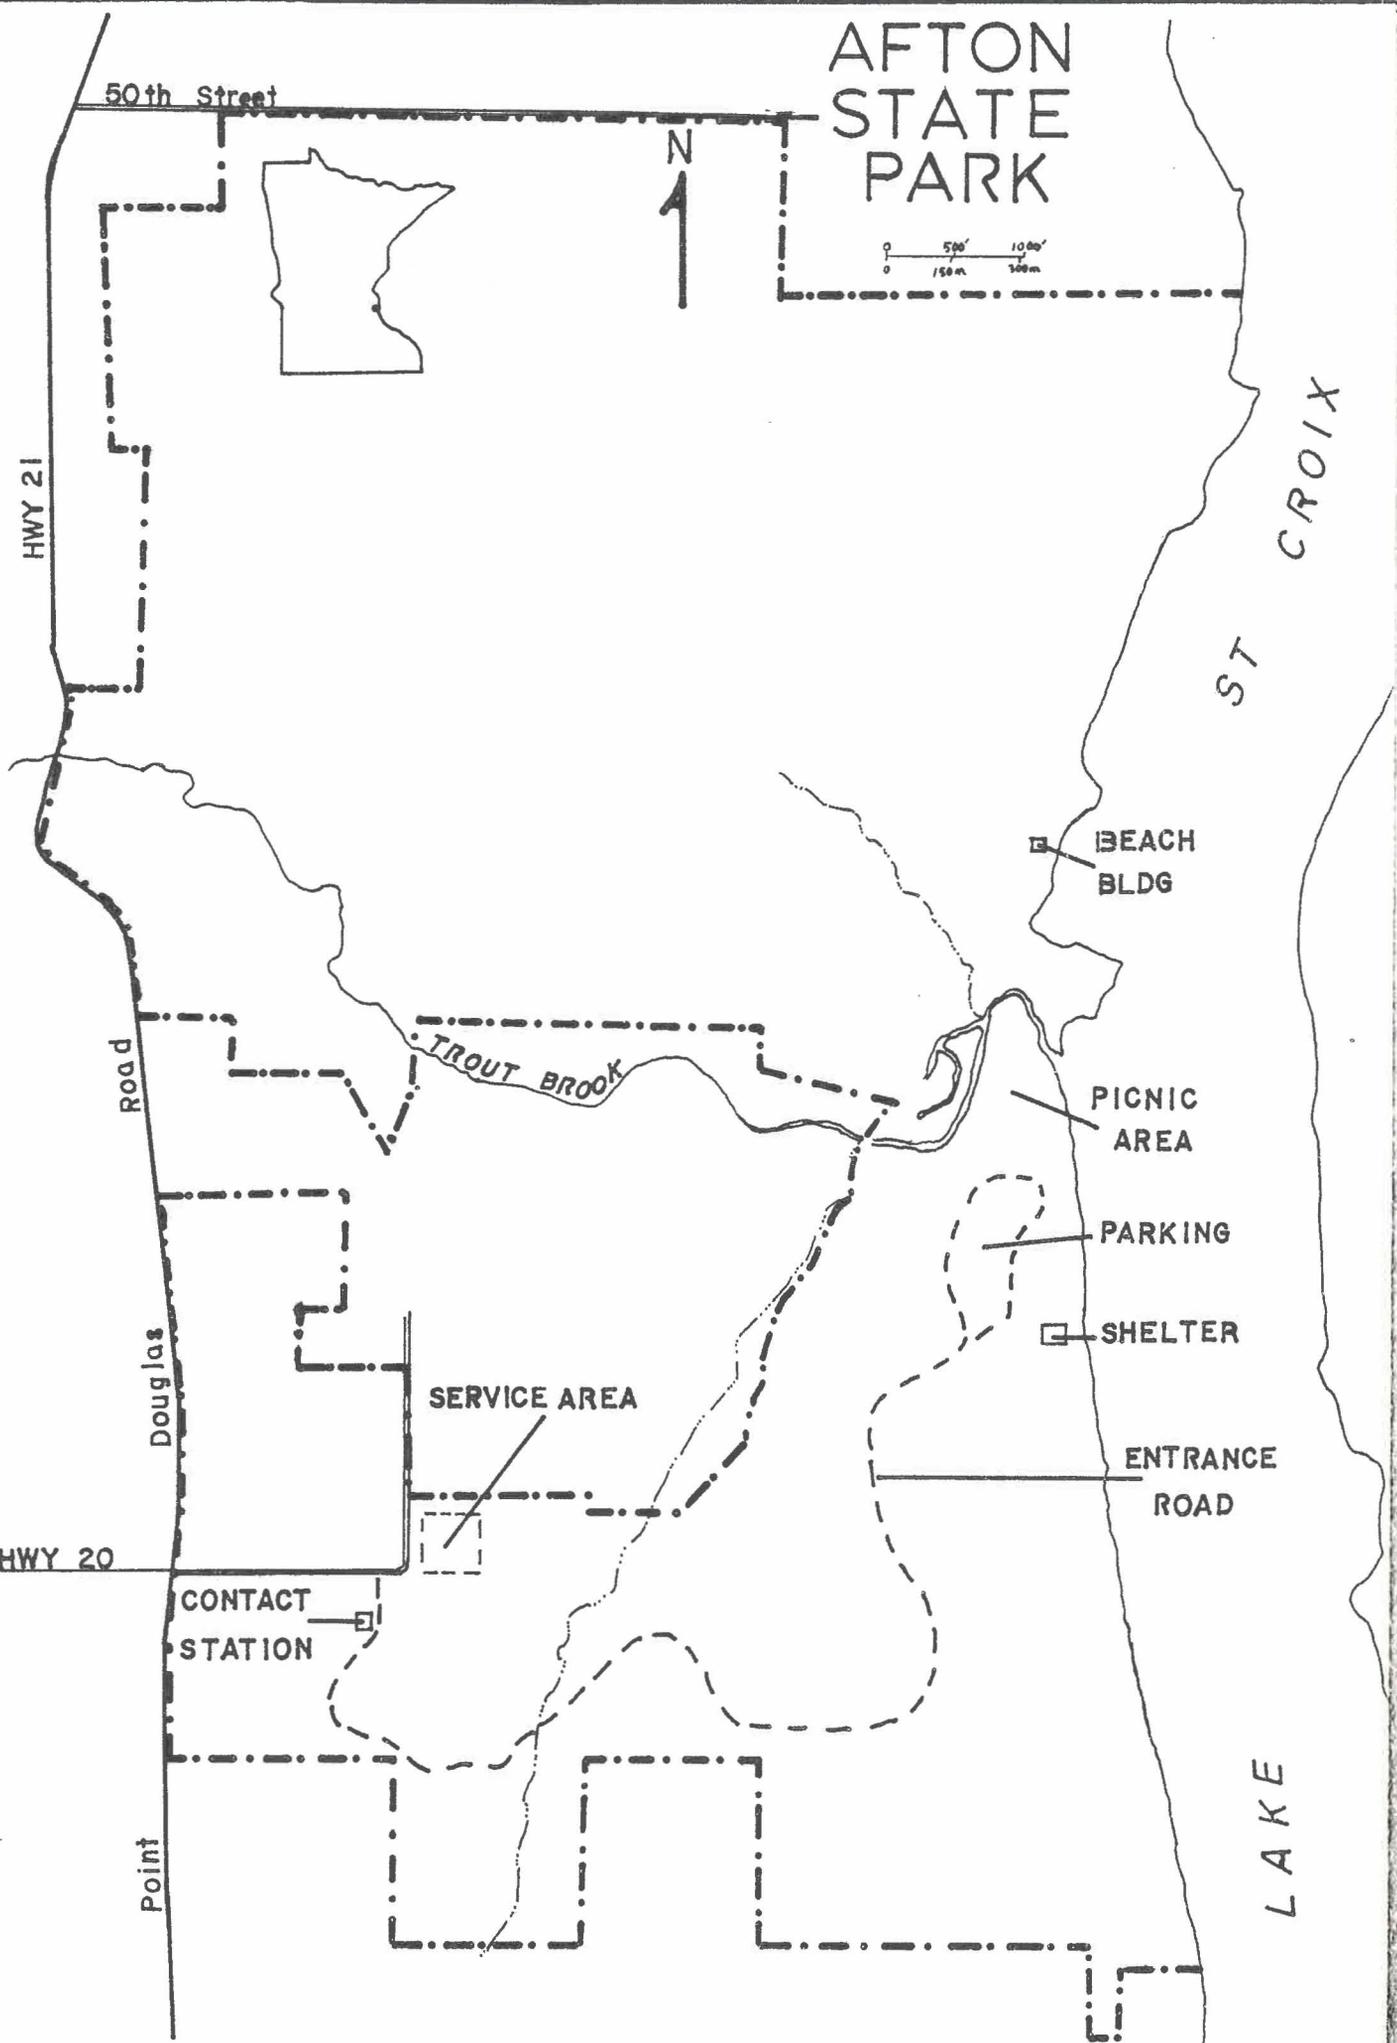
AFTON STATE PARK

The proposed entrance road lies in the N 1/2 of Section 10, the NW 1/4 of Section 11, and the W 1/2 of Section 2 Twp 27N R 20W. It begins east of County Road 21, just off Co. Road 20. It starts where the proposed Contact Station will stand, in a plowed field. The road will run south across the field, over a steep hill and down its side into a deep ravine following the hill side. The road will cross the intermittent stream which runs through the bottom of the ravine. It will climb out of the ravine and cross another field running east/west. Continuing east, the road will cross a current township road, enter another field, turn north and pass between two small knolls. It will continue in a generally northerly direction through additional plowed fields until it reaches an area overlooking the St. Croix where it will terminate in a parking lot under the current power transmission line (see map 1).

The proposed beach building will be in the SE 1/4, SW 1/4 of Section 35 Twp 28N R20W. The area is on the first terrace above the St. Croix River north of Trout Brook as it empties in the St. Croix. The beach building will sit on an abandoned rail road bed. The railroad cuts through a hill at this location, so there is no remaining natural soil surface. The area is badly disturbed. (see map 1).

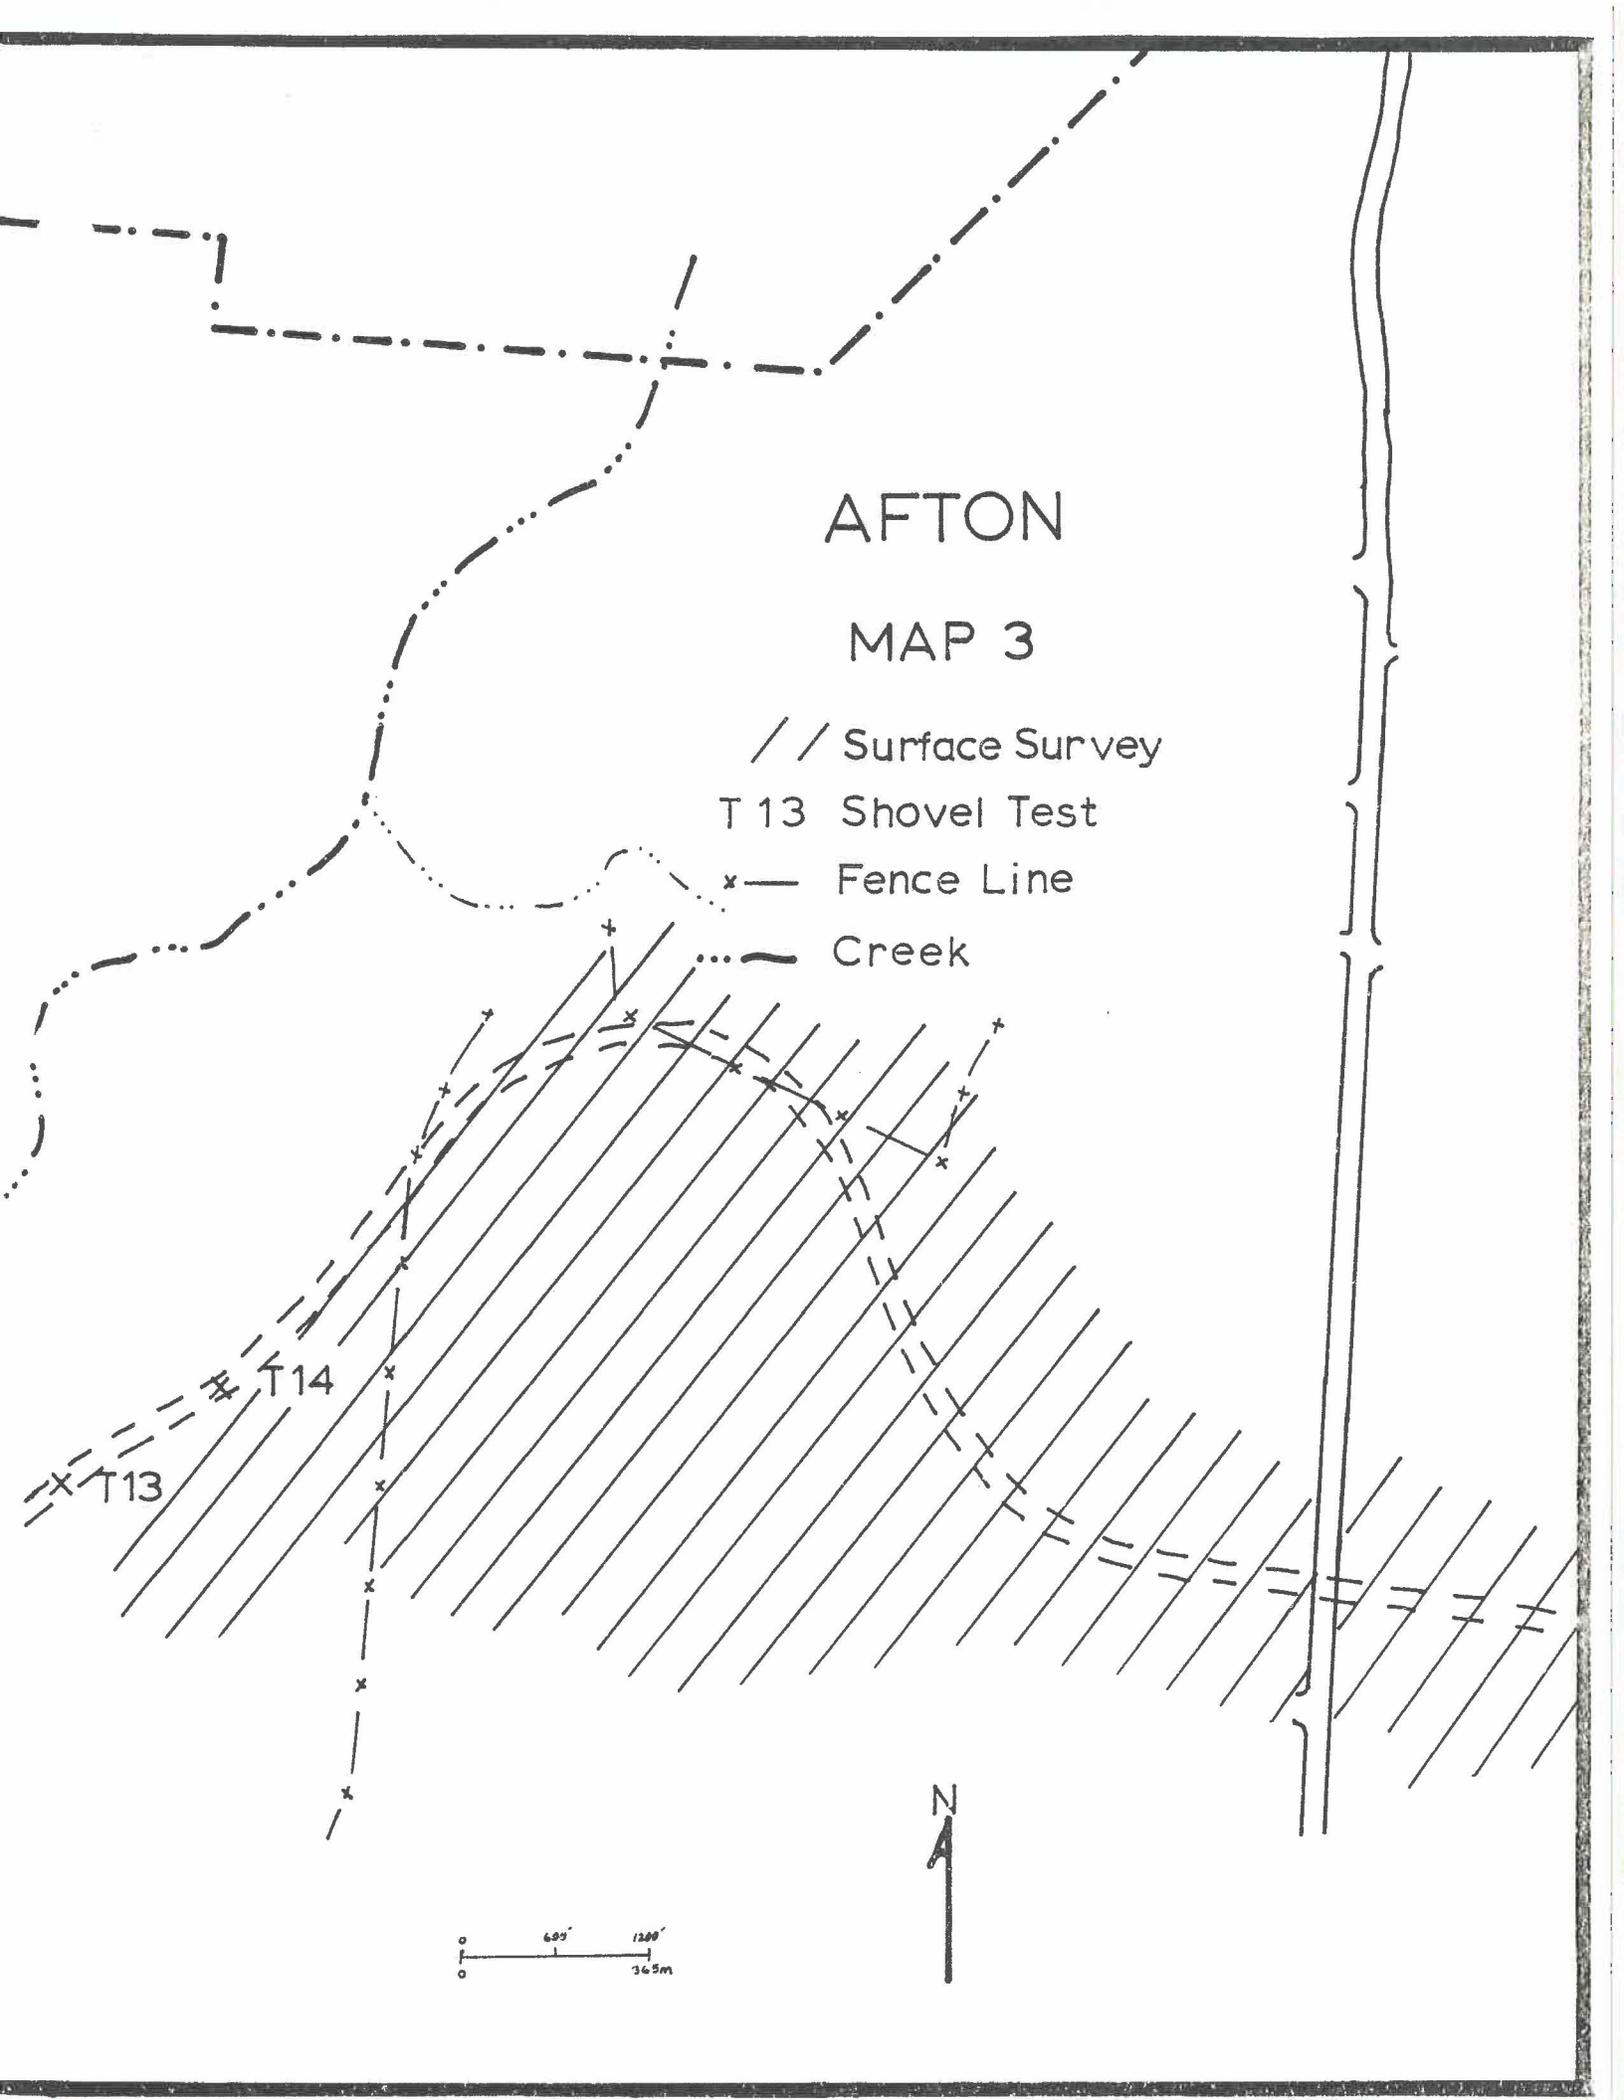
MAP 3

The entire route was walked twice to observe any obvious signs of cultural resources. Most of the route runs through plowed fields which provided excellent visibility. Areas not plowed were shovel tested. Each test was approximately 50 x 50cm and excavated to subsoil (see profiles). All soil was screened through a 1/4" mesh screen.

There were fifteen shovel tests dug along the road route. All tests were negative. No material or features were observed during any of the surface examinations.

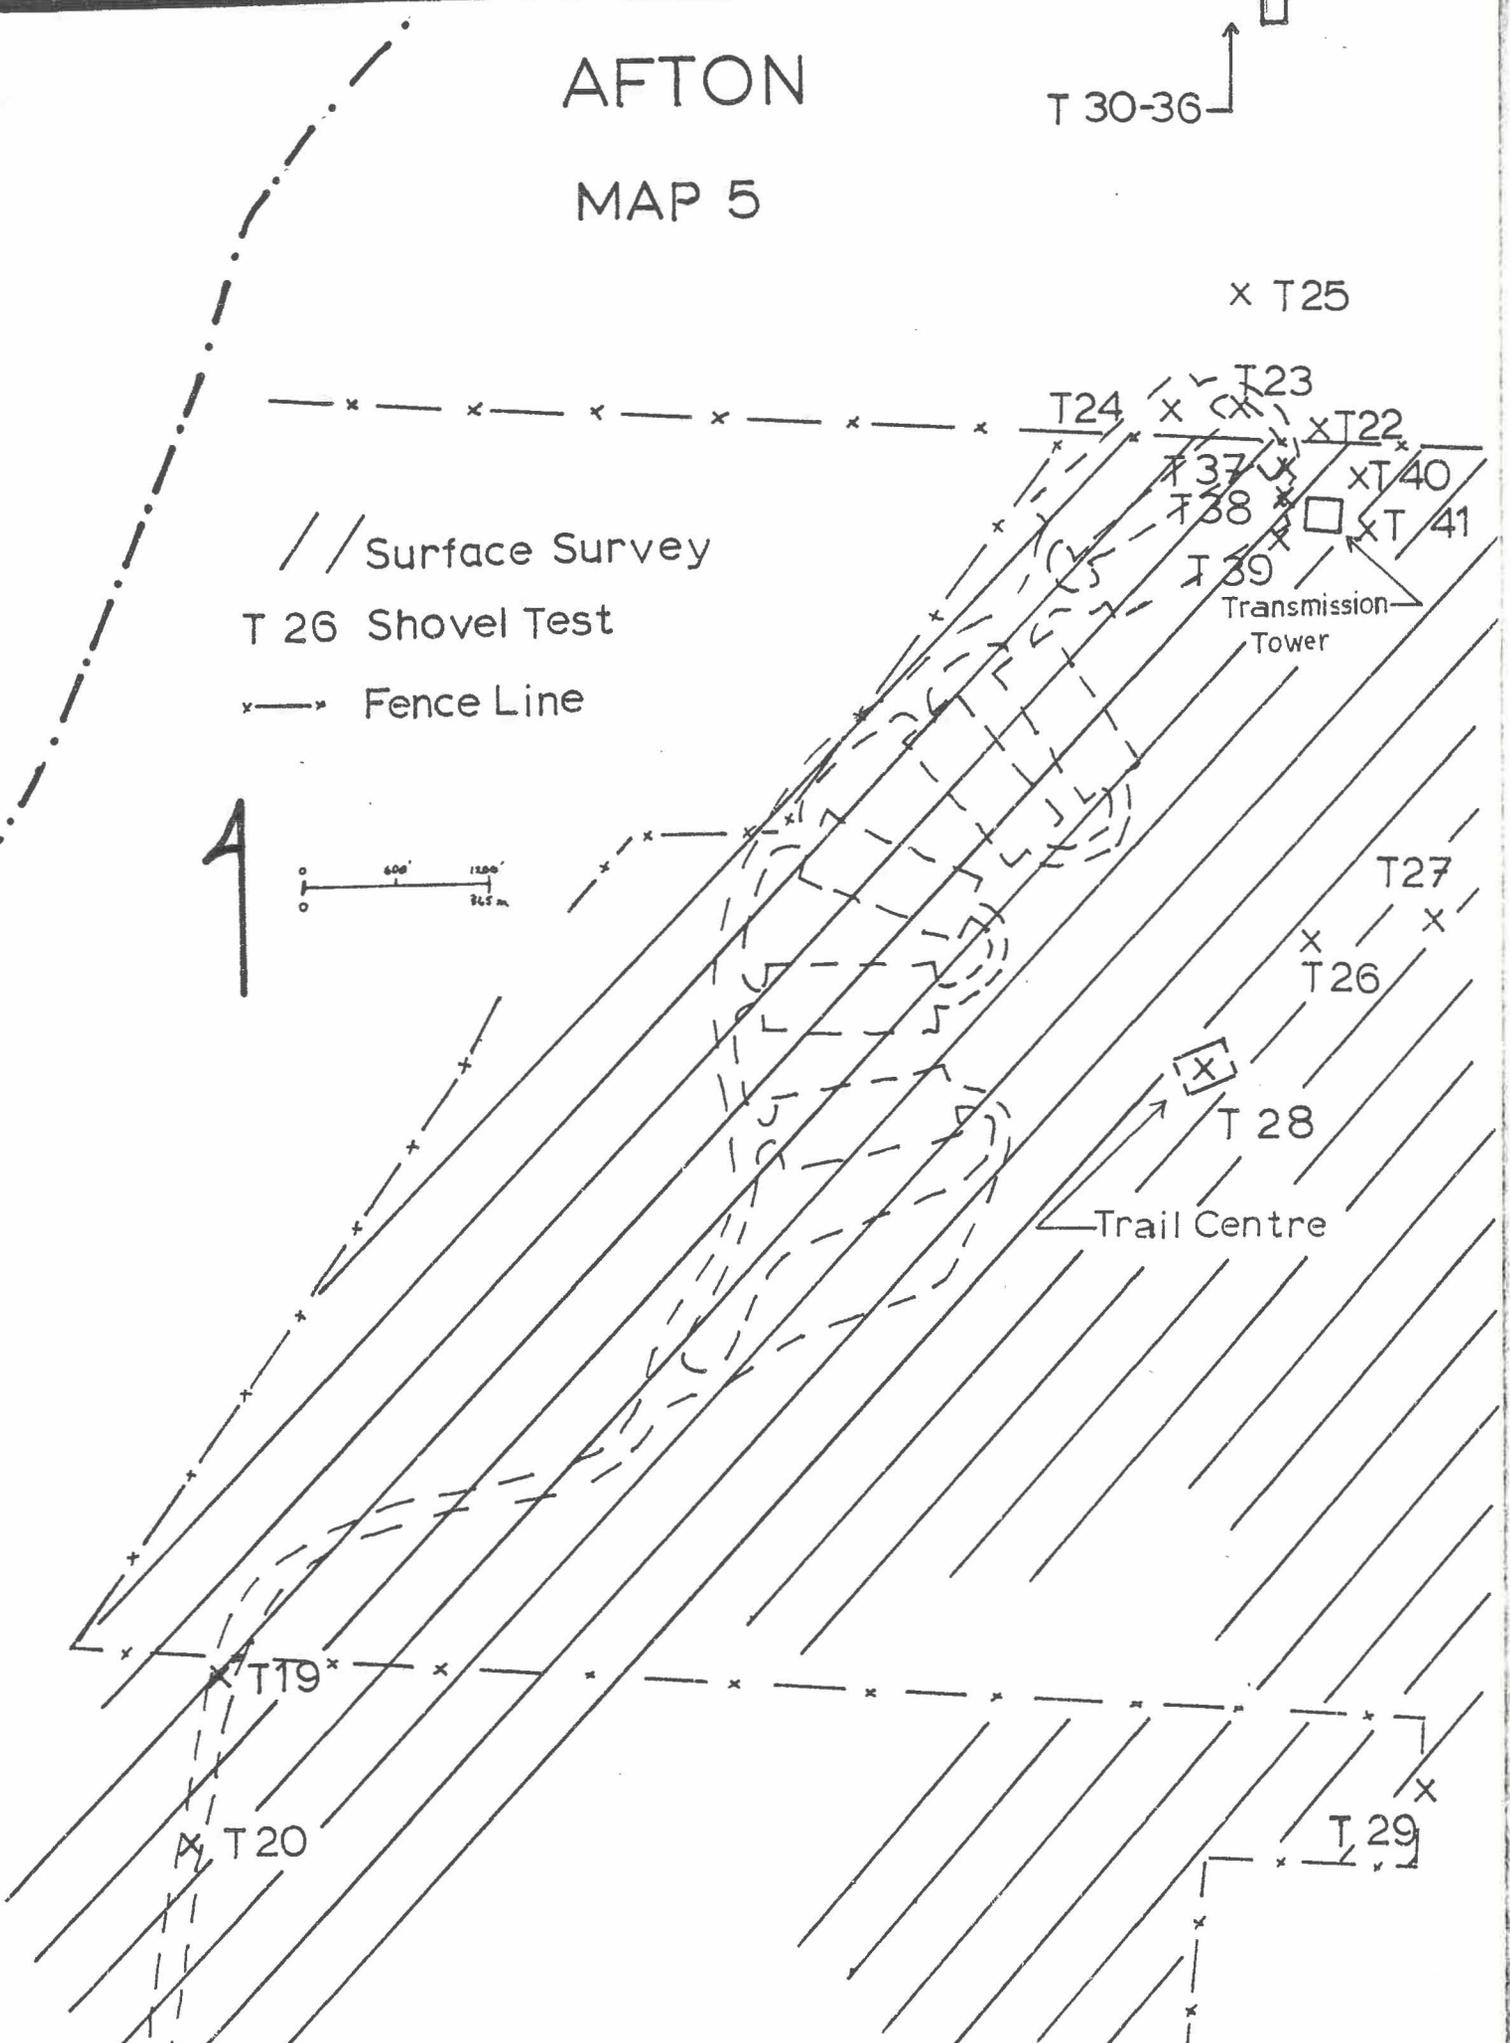
MAP 5

The Trail Building will be in the NE 1/4, SW 1/4 of Section 2 Twp 27N R20W. It will sit on the edge of the upper terrace overlooking the St. Croix and before the bank drops sharply to the river. It is to be excavated into a small hill which at the time of the survey was a cultivated field. (see map 5).

The plowed field was surface checked with negative results. Three tests were placed in the proposed building site (tests #26, 27, 28). All tests were negative.

The picnic area will be located in the NE 1/4, SW 1/4, and the SE 1/4, NW 1/4 of Section 2 Twp 27N R 20W on a terrace overlooking the St. Croix River and Trout Brook. It is the location of an old homestead with a paved drive leading up to the area. There is an existing sanitation building, but all structures from the homestead have been removed, although surface indications still remain from some of the structures. The accompanying parking lot, which will be to the south (between the picnic area and the Trail Building), will be in what is now a cultivated field. (see map 5).

tests were dug in the area between the ridge overlooking Trout Brook on the north and the plowed field (and transmission line) on the south. All tests (#'s 22, 23, 24, 25, 20, 21, 32, 33, 34, 35, 36) were negative. In addition, dozens of rodent mounds were examined and sifted through. None produced any cultural material. The parking lot was walked several times and five shovel tests were dug in the area (tests #37, 38, 39, 40, 41). All were negative.

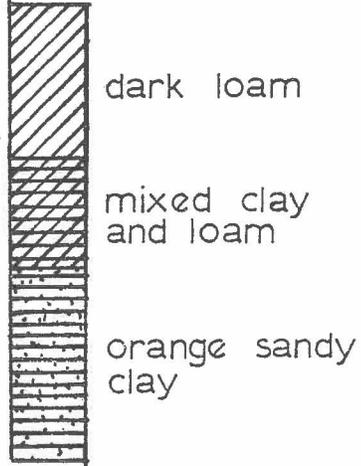
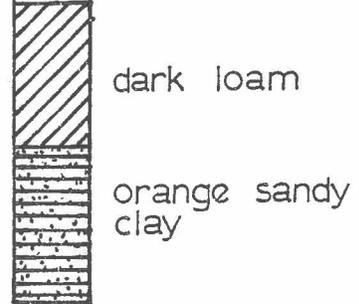
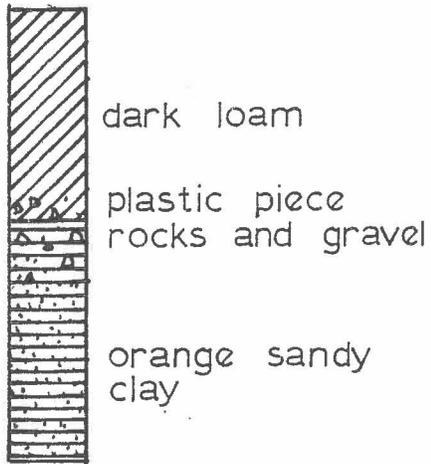
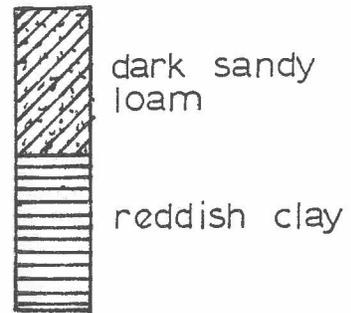
TEST UNIT SOIL PROFILE

dark loam

mixed clay
and loam

orange sandy
clay

plastic piece
rocks and gravel

dark sandy
loam

reddish clay
