DEPARTMENT OF
NATURAL RESOURCES

BUILDING CONSOLIDATION PROPOSAL

PROPOSAL SUMMARY

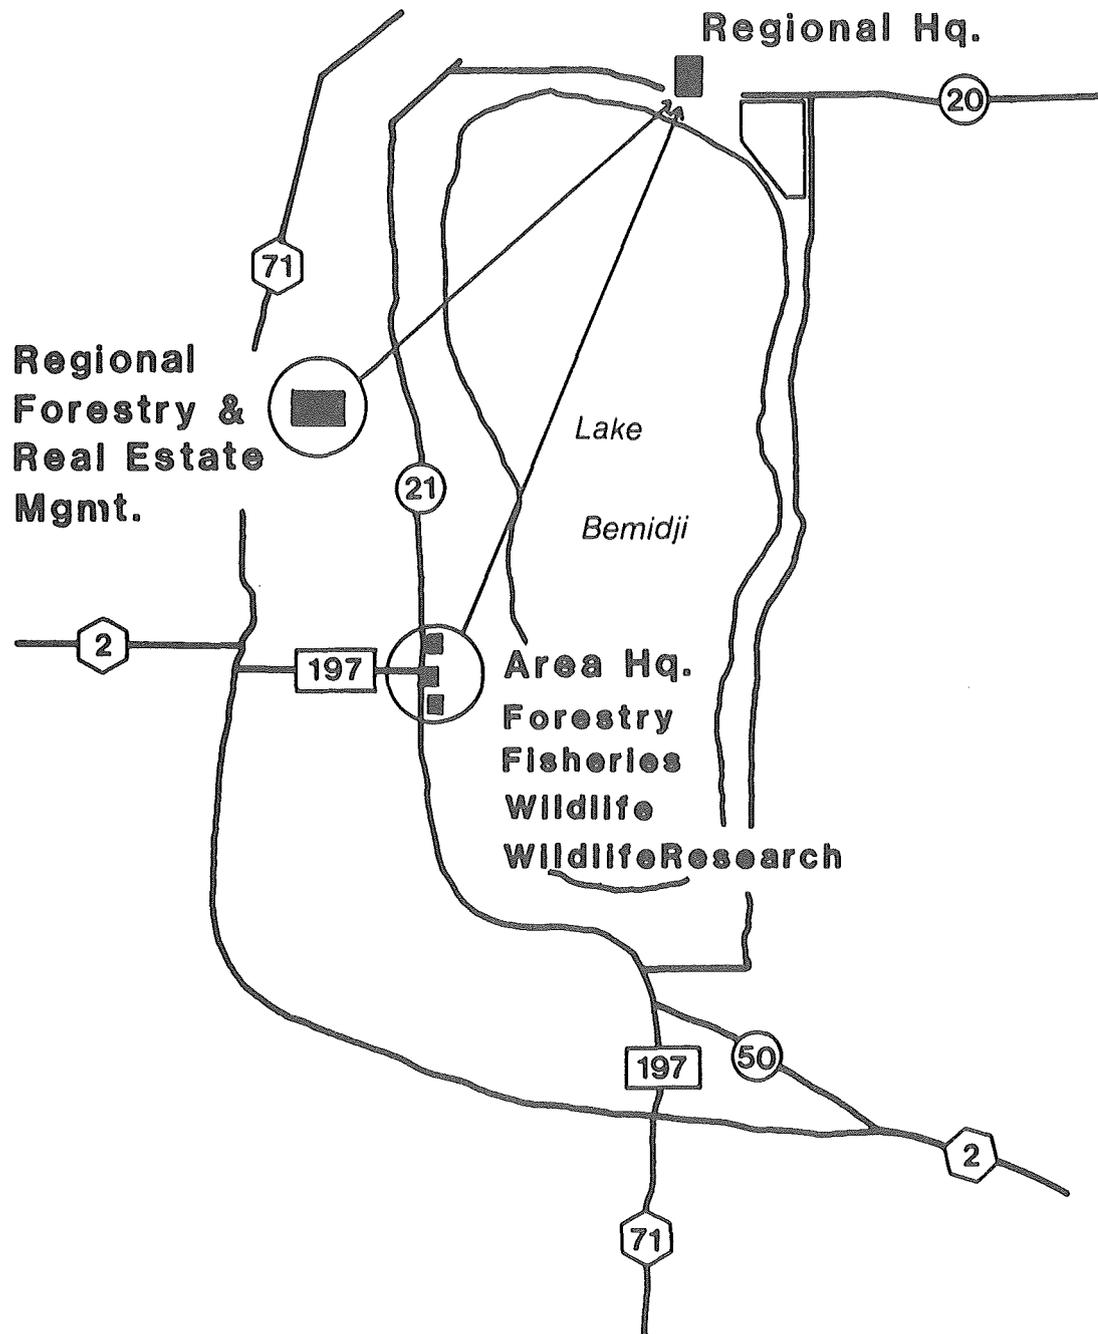
Figure 2: LOCATION OF EXISTING DNR FACILITIES IN BEMIDJI

GENERAL CONDITION OF BUILDINGS: state-owned Area Headquarters facilities are in excess of 50 years old, are overcrowded, and are in need of major investments to create acceptable staff space. The mobile home at the Regional Headquarters may violate state building codes. Wildlife Research is in a residential type of facility and uses non-complying basement space to house staff. It would be more cost effective and administratively efficient to consolidate all facilities and staff at the Bemidji Regional Headquarters facility.

1. no handicapped access at most facilities
2. combustible finishes
3. inadequate ventilation at several facilities
4. high energy consumption at several facilities
5. inadequate toilets at several facilities
6. inadequate lighting and wiring at several facilities

The existing Regional Headquarters should be remodeled and an addition constructed that includes adequate office, conference, lunch room, storage, and parking space. The estimated cost of construction for the remodeled space (8,584 sq. ft.), a new addition (21,500 sq. ft.), site improvements, land acquisition, storage, elevator, and a wood heating system is \$3.15 million.

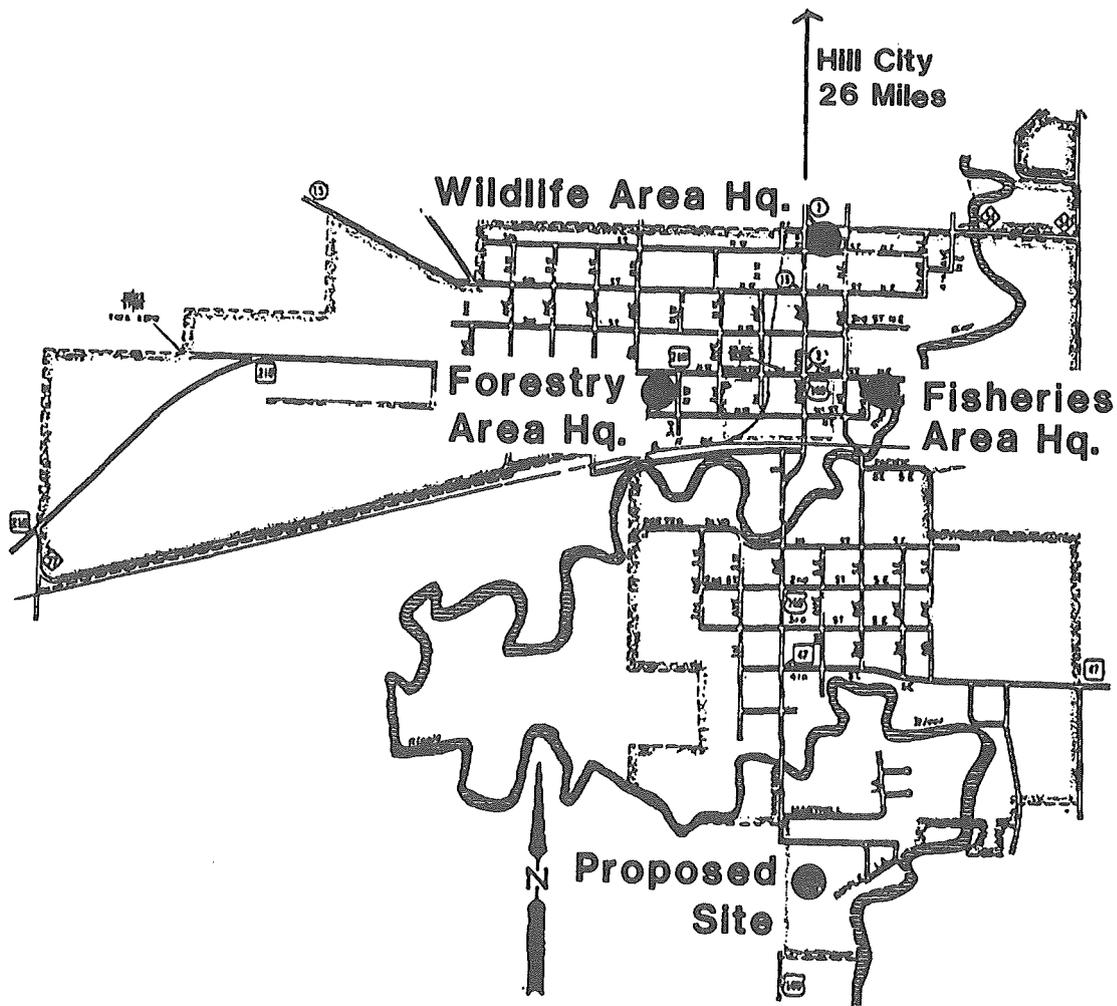
Figure 3:

GENERAL CONDITION OF BUILDINGS: The general condition of these four facilities is poor. Three of the sites are in need of major improvements. There is little possibility of expanding any one of them to serve as a consolidated facility for the four offices.

1. no handicapped access
2. inadequate ventilation
3. inadequate wiring
4. poor lighting
5. high energy consumption
6. inadequate toilet facilities
7. fish holding tanks needed at Fisheries office.

LOCATION OF EXISTING DNR FACILITIES IN AITKIN

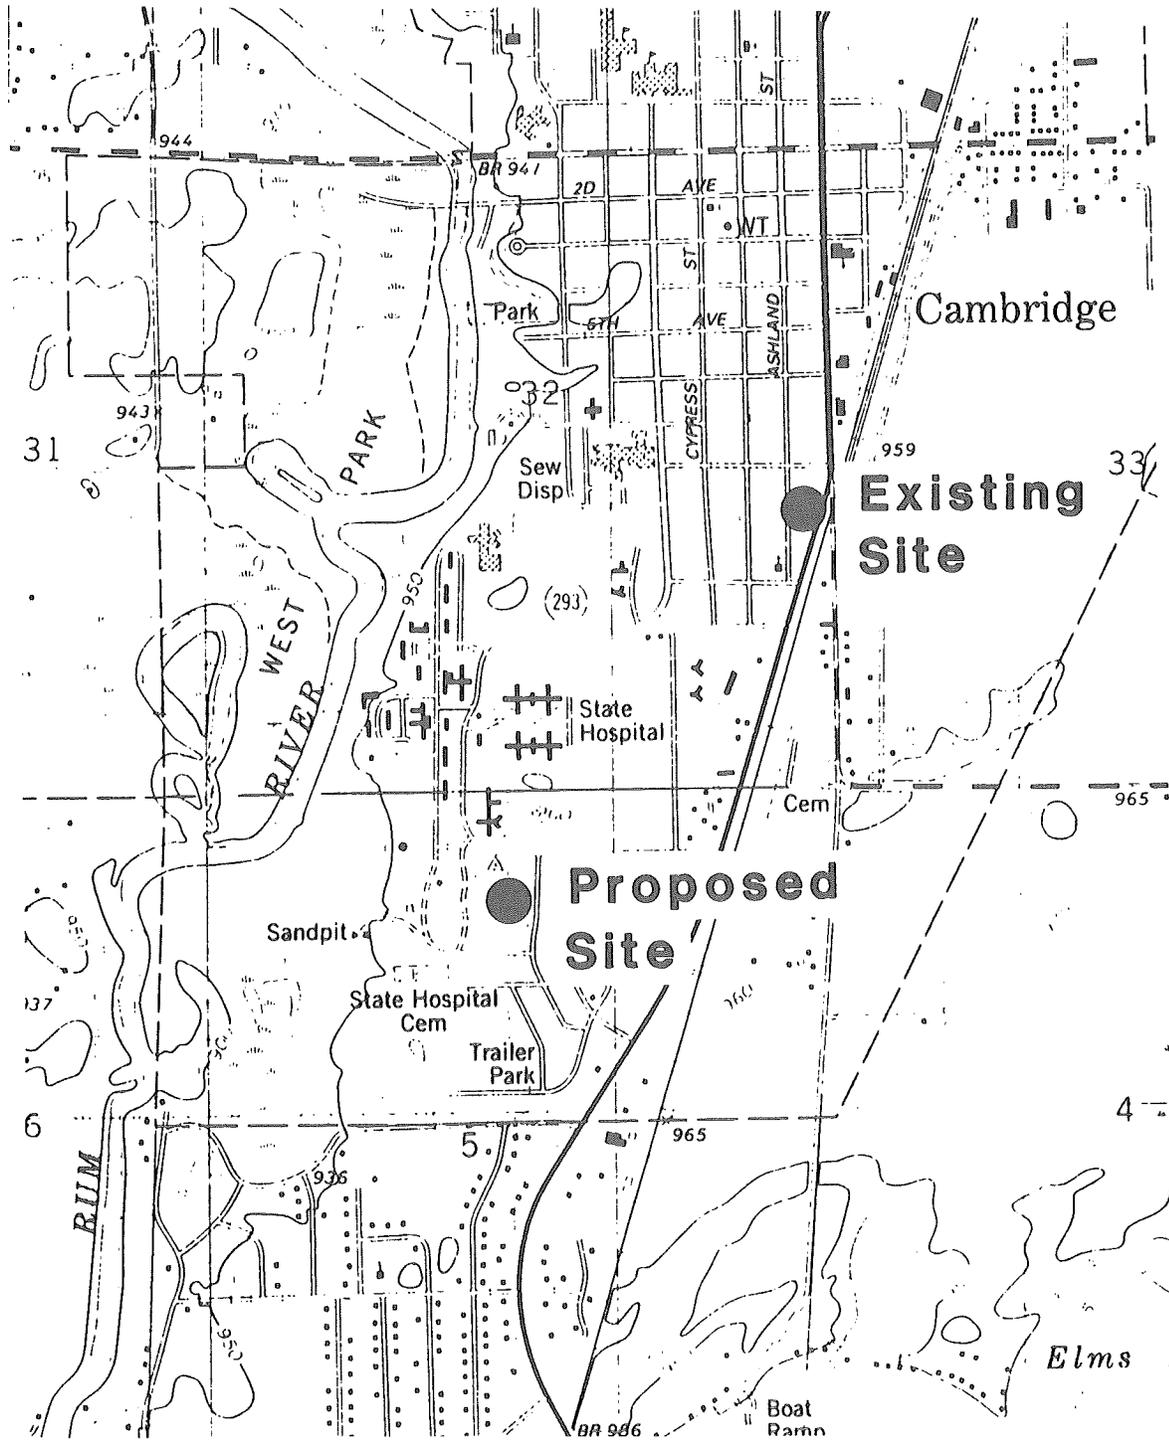
Figure 4: LOCATION OF EXISTING AND PROPOSED SITES OF DNR FACILITIES IN CAMBRIDGE

GENERAL CONDITION OF BUILDING: The general condition of this building is poor. The headquarters is limited to a site of about six tenths of an acre. It has little or no parking available for employees and the public. Emergency and other DNR vehicles occupy most available space. All personnel park on residential streets. Expansion and continued occupancy of this building is unfeasible.

1. no handicapped access
2. inadequate ventilation.
3. inadequate basement exits
4. high energy consumption
5. inadequate toilet facilities

The proposal is to secure and develop a site, construct an office building to adequately house staff and serve the public, and to construct a shop/storage building for equipment. The estimated cost for an office (4,500 sq. ft.) and shop/storage (7,200 sq. ft.) is \$560,000.

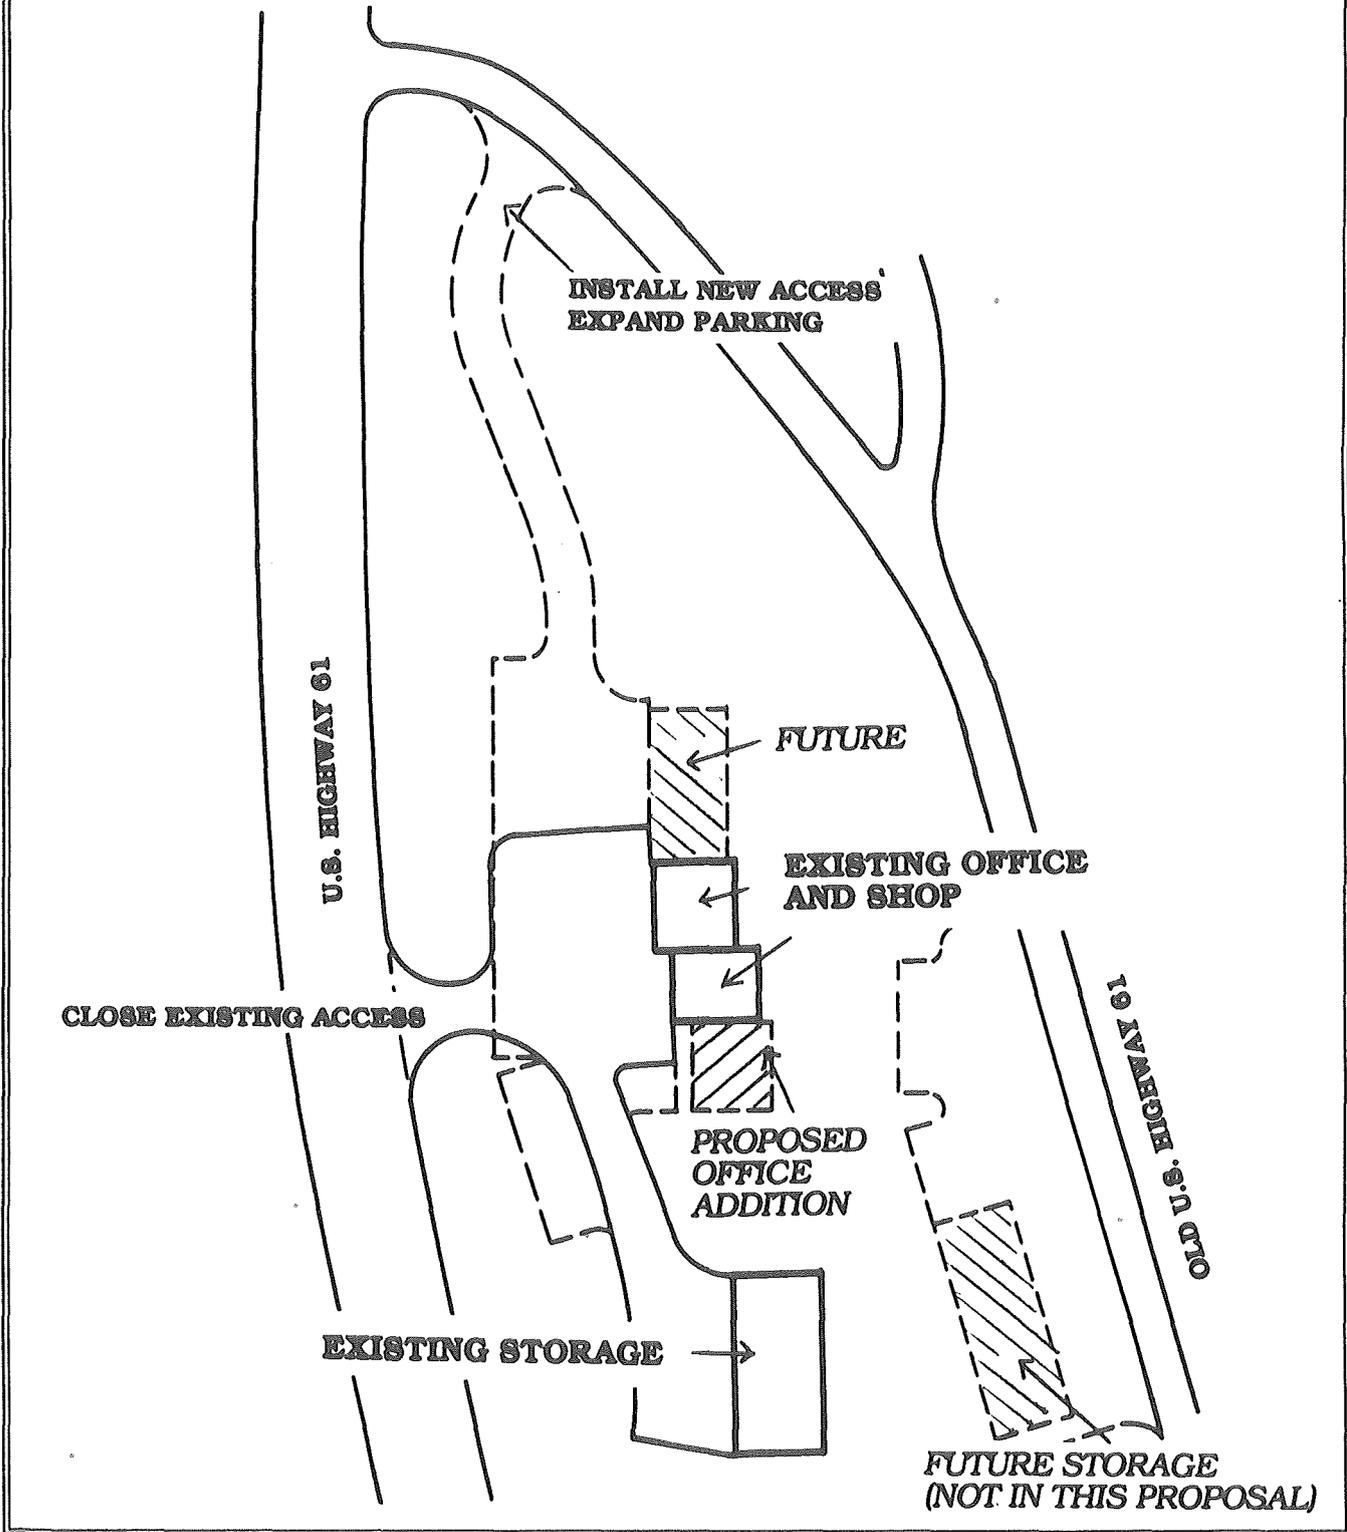
Figure 5: PROPOSED CHANGES AT DNR GRAND MARAIS FACILITY

GENERAL CONDITION OF BUILDING: The existing building shell is in good condition. Some mechanical and finish improvements are needed along with a building expansion. With those improvements, the building can continue to be used.

1. inadequate toilet facilities
2. combustible finishes
3. no handicapped access
4. inadequate temperature controls
5. inadequate parking
6. inadequate public access
7. non-complying necropsy laboratory

The existing office space should be remodeled and a new addition developed. The estimated cost to construct a 1,440 sq. ft. addition, remodel 1,080 sq. ft. of existing office space and for site improvements is \$183,000.

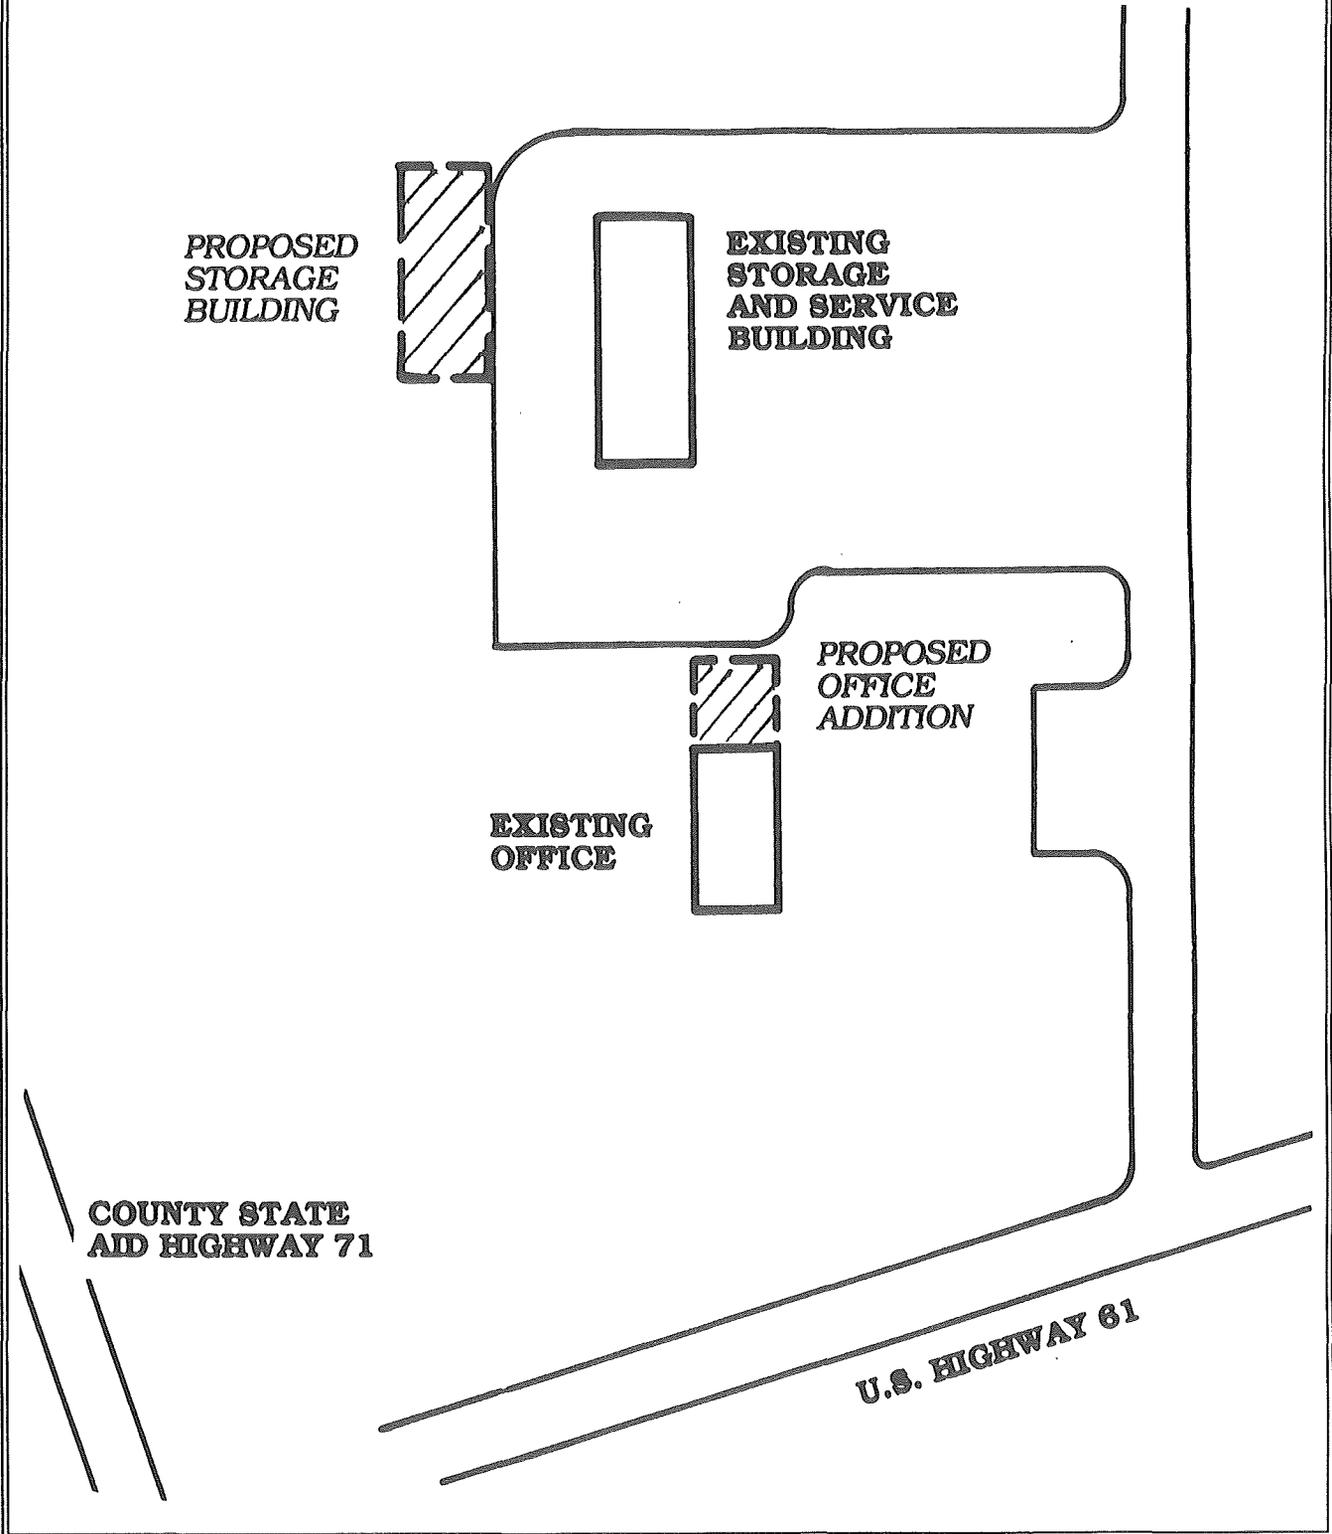
Figure 6:

GENERAL CONDITION OF BUILDING: The present building is in good condition though it needs modernization and expansion to accommodate DNR staff and public.

1. no handicapped access
2. inadequate ventilation and air conditioning
3. inadequate basement exits
4. inadequate toilets

**EXISTING AND PROPOSED STRUCTURES
AT DNR MOOSE LAKE FACILITY**

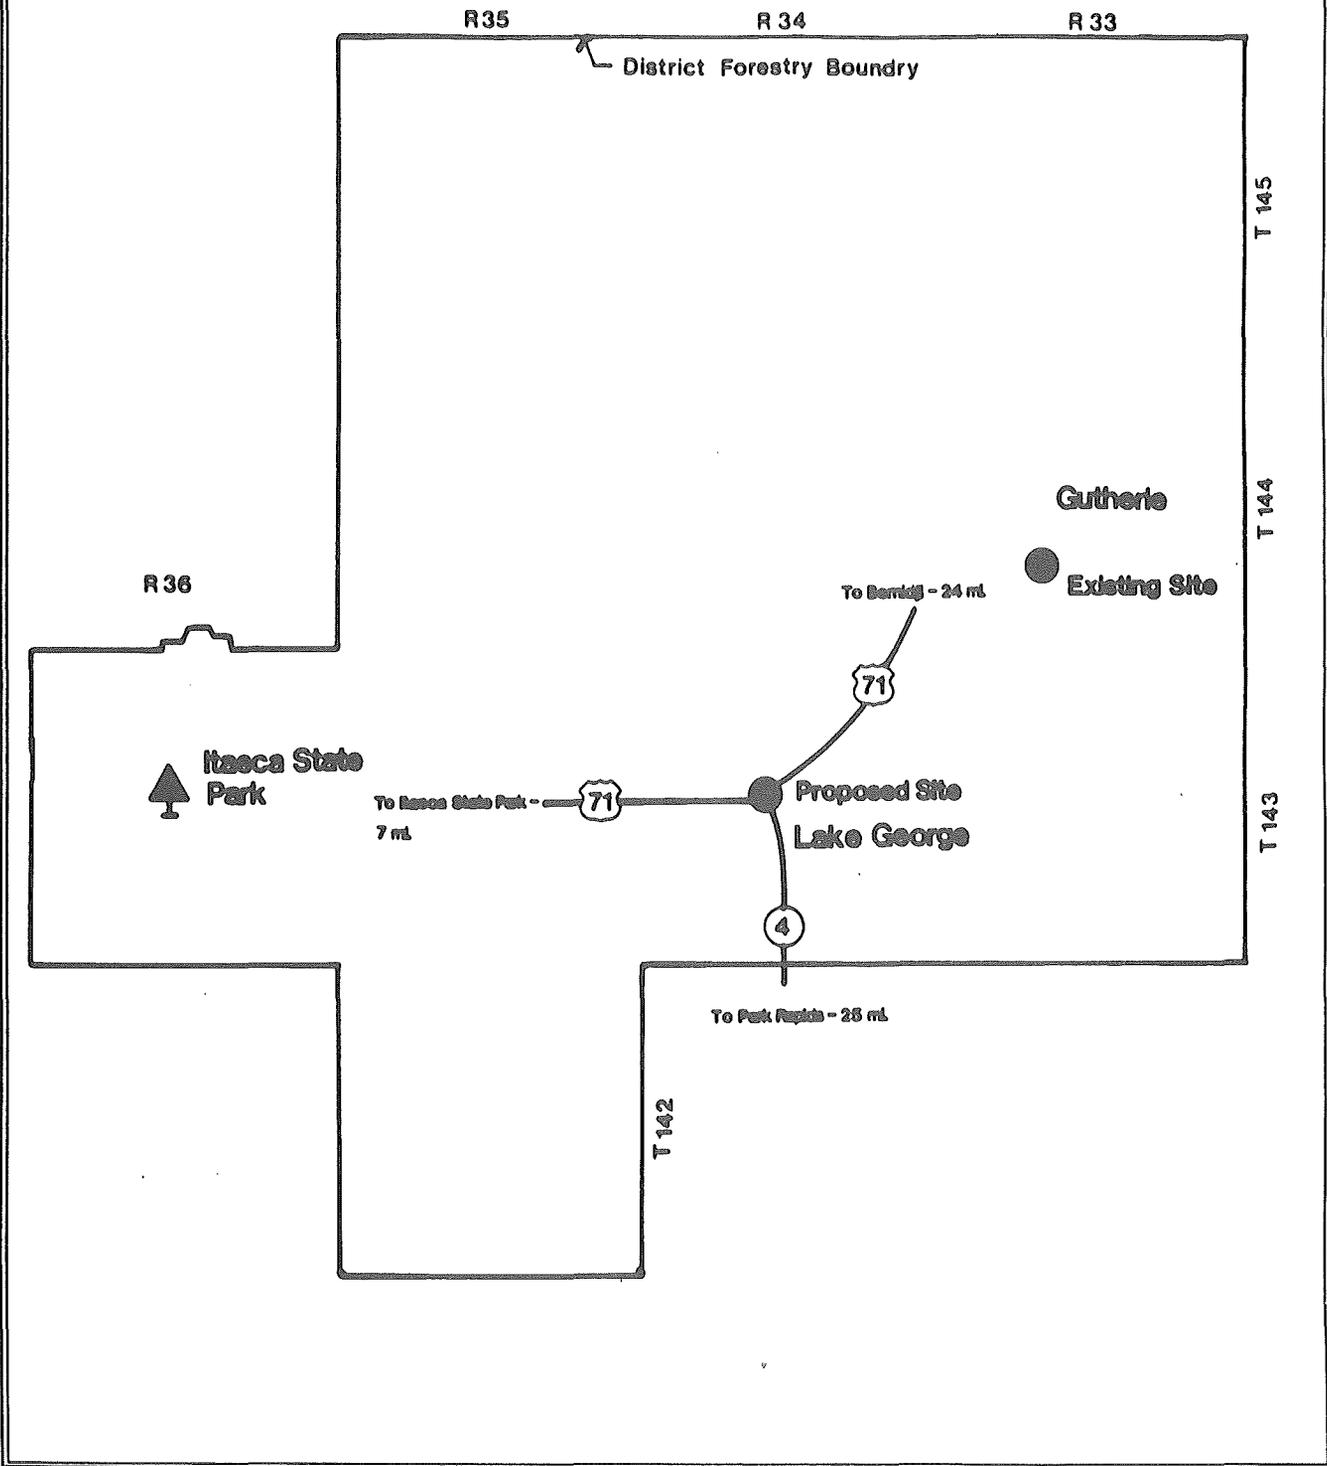
Figure 7:

GENERAL CONDITION OF BUILDING: The general condition of the existing facility in Guthrie is acceptable but is approaching the end of its design life. Substantial expenditures will be required to upgrade and expand it to meet current demands. Those expenditures would be imprudent given the poor location of the facility with respect to the area it services.

1. obsolete electrical and mechanical systems
2. inadequate toilet facilities
3. building components that form the energy envelope are old and ineffective.

LOCATION OF EXISTING DNR FACILITY AT GUTHRIE AND PROPOSED LOCATION AT LAKE GEORGE

The Guthrie District Forestry Station facility is inadequate for the current use and its strategic location is poor with respect to the area it services. Up to 12 existing buildings could be eliminated with a combined facility at Lake George.

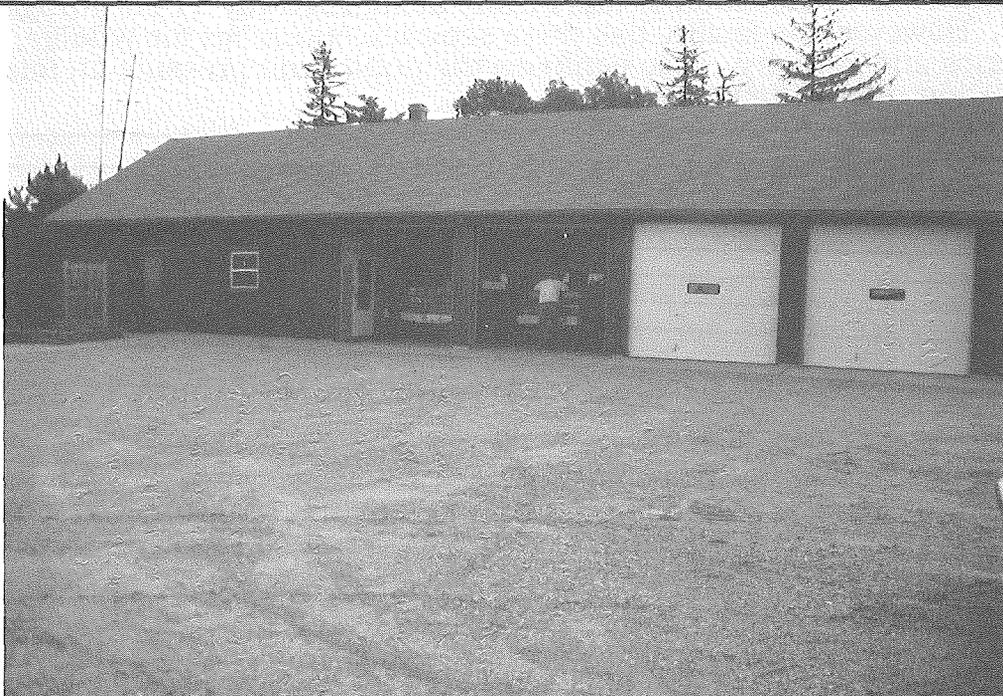
A building addition should be constructed that includes office, meeting and public space and the heating and cooling system should be upgraded. An office addition (900 sq. ft.) plus improvements would cost an estimated \$97,000.

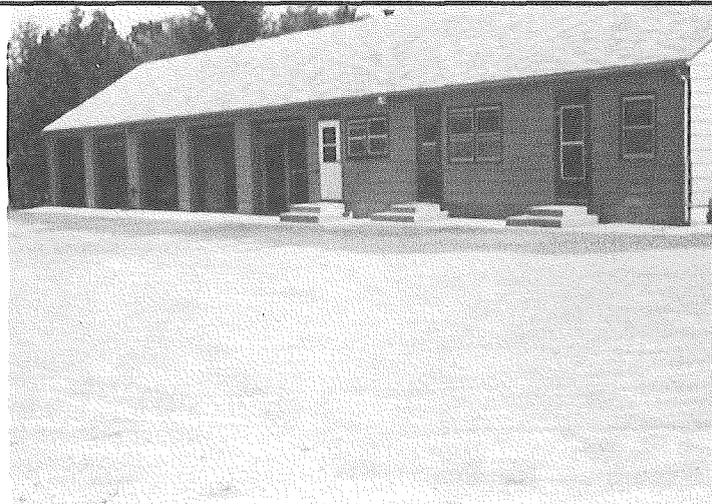
An addition should be constructed that would provide additional office space, more parking, better public reception area, and improved space for staff circulation and habitability. An addition of 936 sq. ft. and remodeling of 800 sq. ft. will cost an estimated \$90,000.

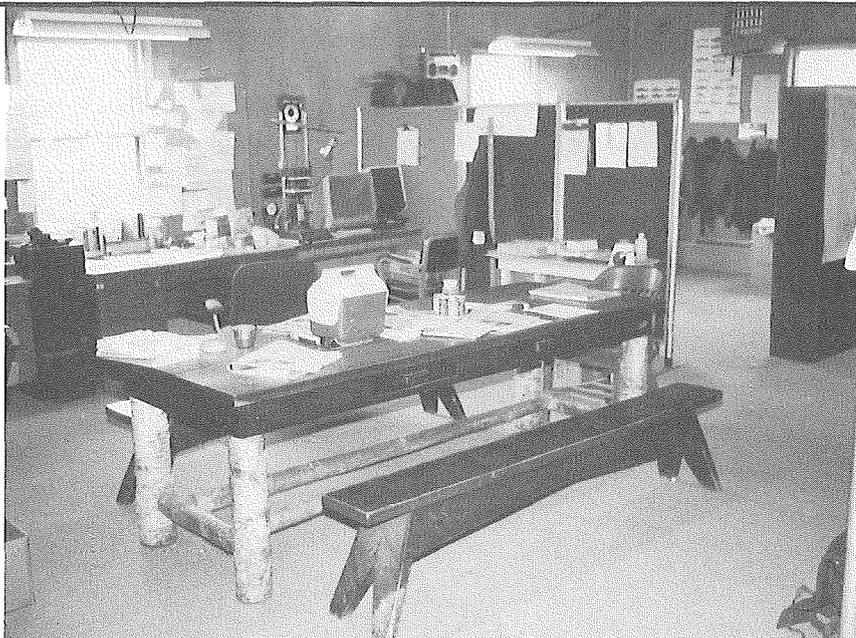
This Area Headquarters office facility provides an unprofessional and unhealthy environment for employees. The make-shift offices in the converted garage stalls are, at best, a temporary measure. Employees suffer from very cold office temperatures. Heating efficiency is very low. Vehicles and equipment that should be stored indoors are kept outside.

The existing area site and buildings should be abandoned or disposed of. A site in Ely should be acquired and developed for a combined Area Headquarters and Northeast Minnesota Fish and Wildlife Research Center. An office, library and laboratory building should be constructed with adequate public space. Heated and unheated storage buildings must also be provided.
