**INVESTIGATION OF
SEDIMENT & VEGETATION PROBLEMS
LITTLE FALLS RESERVOIR - LITTLE FALLS, MINNESOTA**

**MINNESOTA DEPARTMENT OF NATURAL RESOURCES &
MINNESOTA DEPARTMENT OF TRANSPORTATION**

March 1993

Principal Author: David R. Ford, Surface Water Engineer
Minnesota Department of Natural Resources
Division of Waters

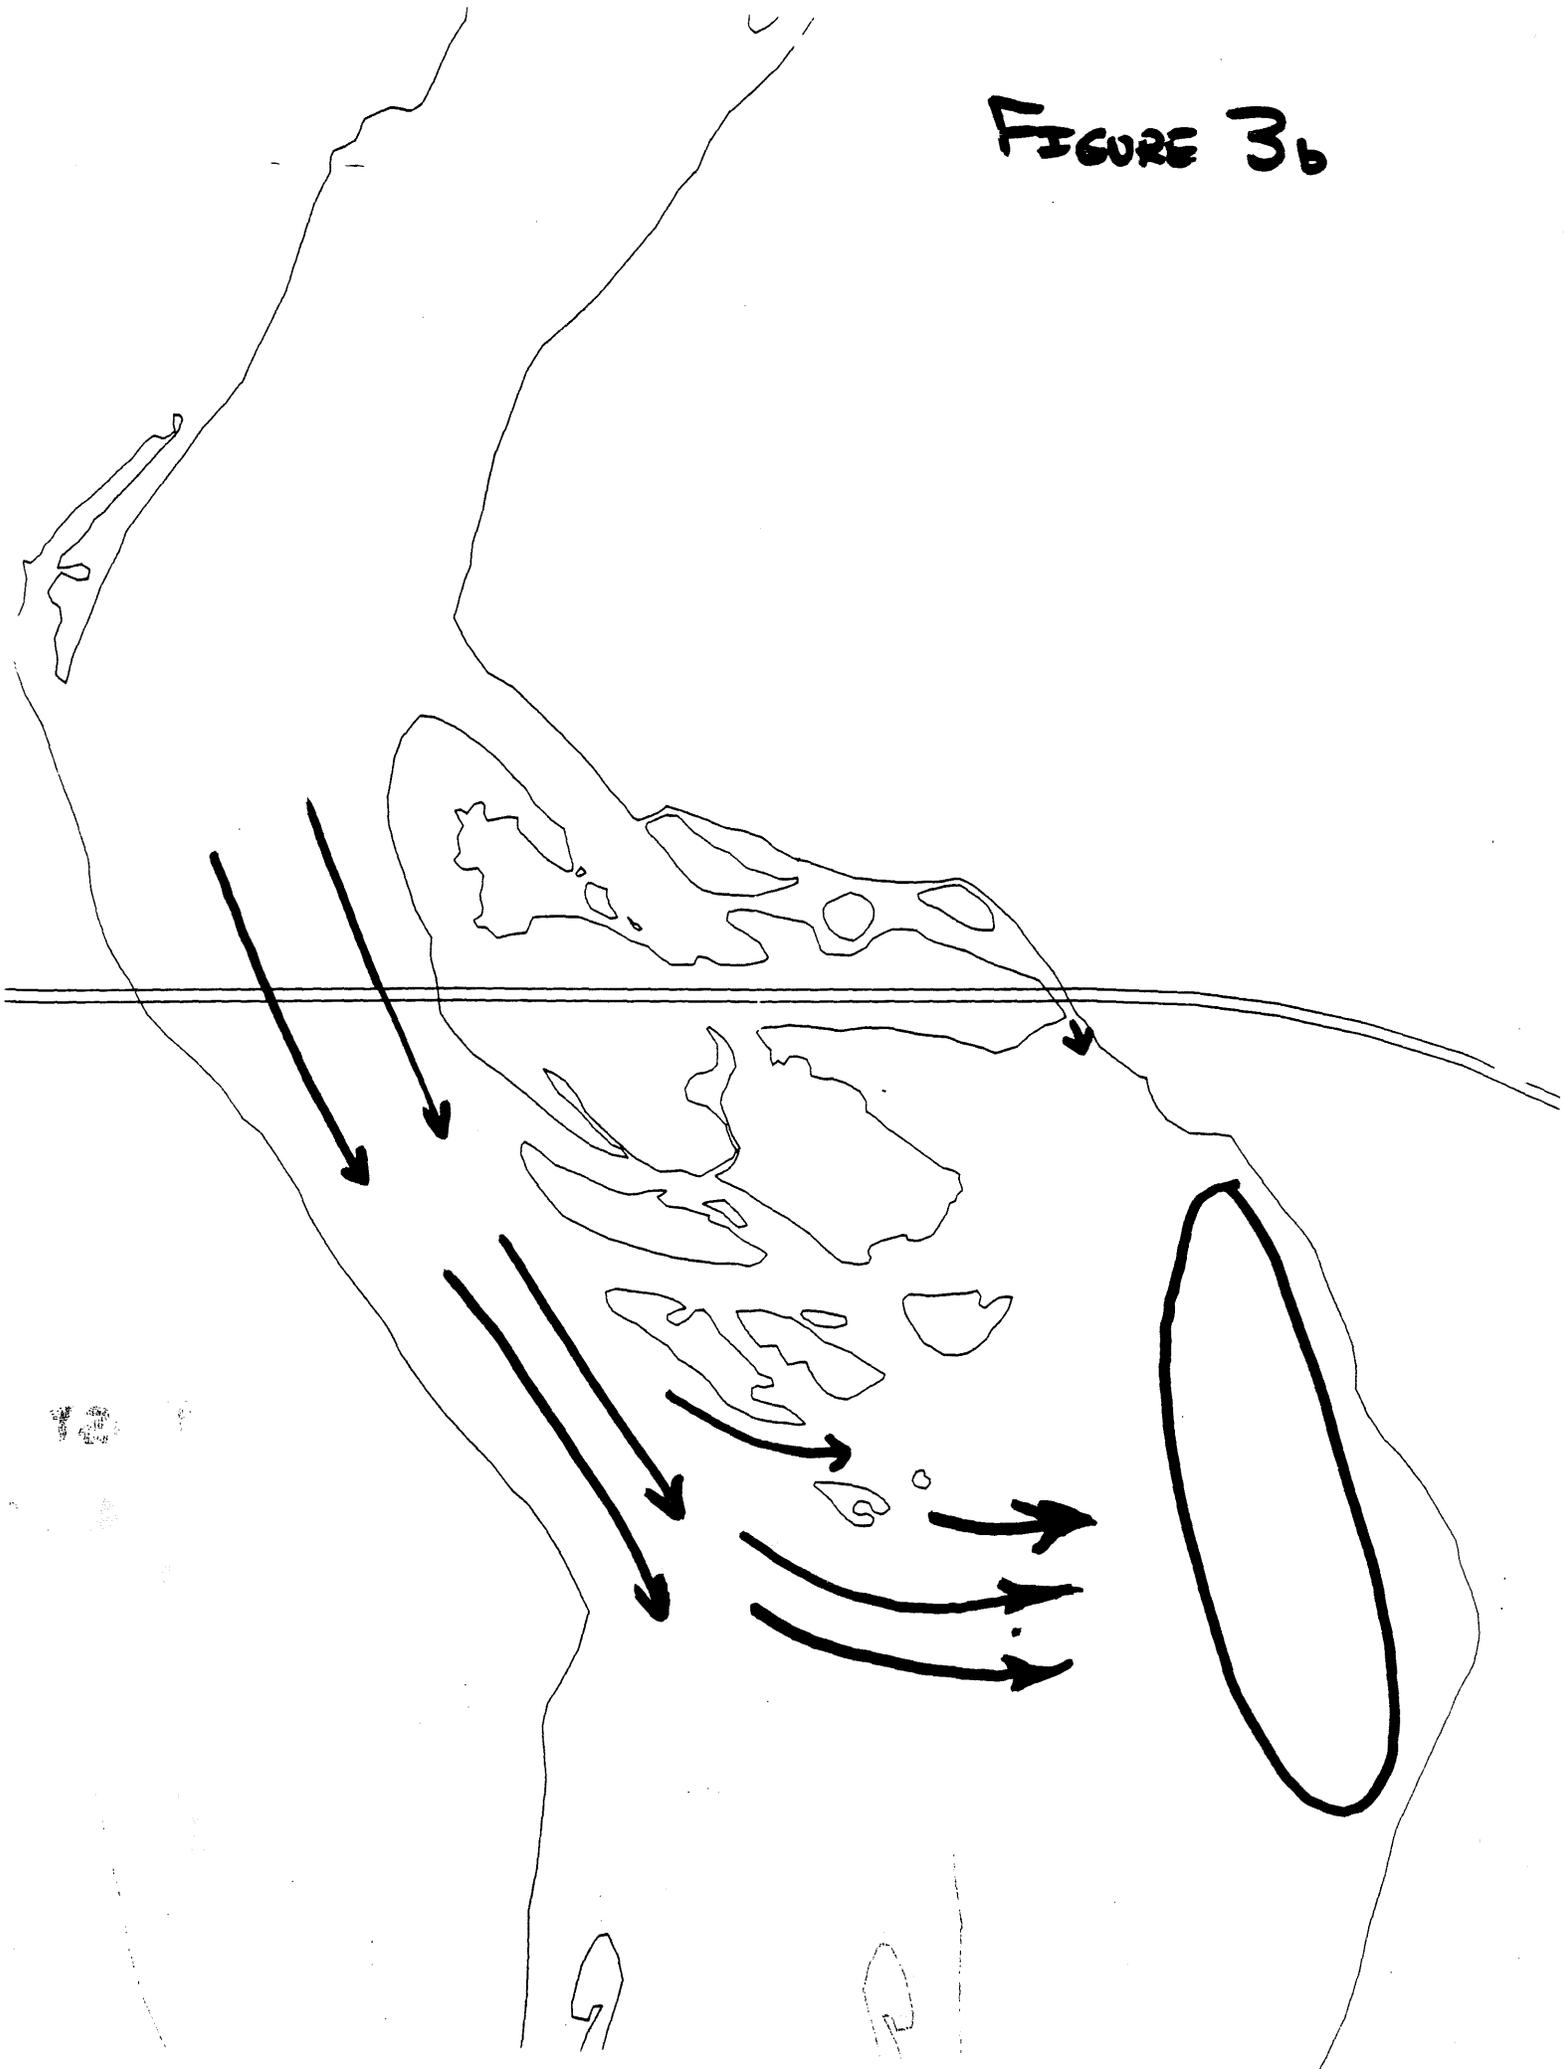
FIGURE 3b

The above analysis suggests that the closure of the east channel has, if anything, acted to reduce the deposition of sand near the east bank. The same, however, is not necessarily true of finer material. Finer material tends to be transported across the delta front and out into deeper and/or wider slack water, where it slowly settles out. Closure of the east channel may have modified the deposition patterns of this sediment. The process is schematized in Figure 3. The jet from the mouth of the delta may have helped keep a region along the east bank from relatively clear of fine material. Closure of the east bank would have created a zone of relatively slower-flowing water, in which the deposition of fines would have been promoted.

ZONES OF MAXIMUM FINES
DEPOSITION WITH EAST
CHANNEL OPEN
